STAR ONLINE PUBLICATION

Case Number: S2208000064

Symptom/Vehicle Issue: Check Engine Light Is On. P0480 Cooling Fan 1 Control

Circuit/Open

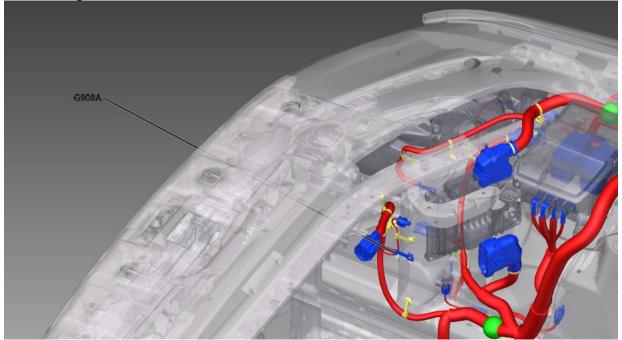
Discussion: The customer may bring in their vehicle because the check engine light (MIL) is on. Upon scanning the vehicle for DTC's you may find P0480 Cooling Fan 1 Control Circuit/Open. This may be caused by the ground wire not being fully welded/secured to the ground eyelet.

Diagnosis: Inspect the G908A ground located in the engine bay, below the PCM behind the passenger side headlight. Determine if the ground eyelet is properly

secured to the ground wire.

Repair Procedure: It is recommended to spot solder the ground wire onto the eyelet terminal.
