STAR ONLINE PUBLICATION

Case Number: S2208000077

Symptom/Vehicle Issue: No Crank No Start

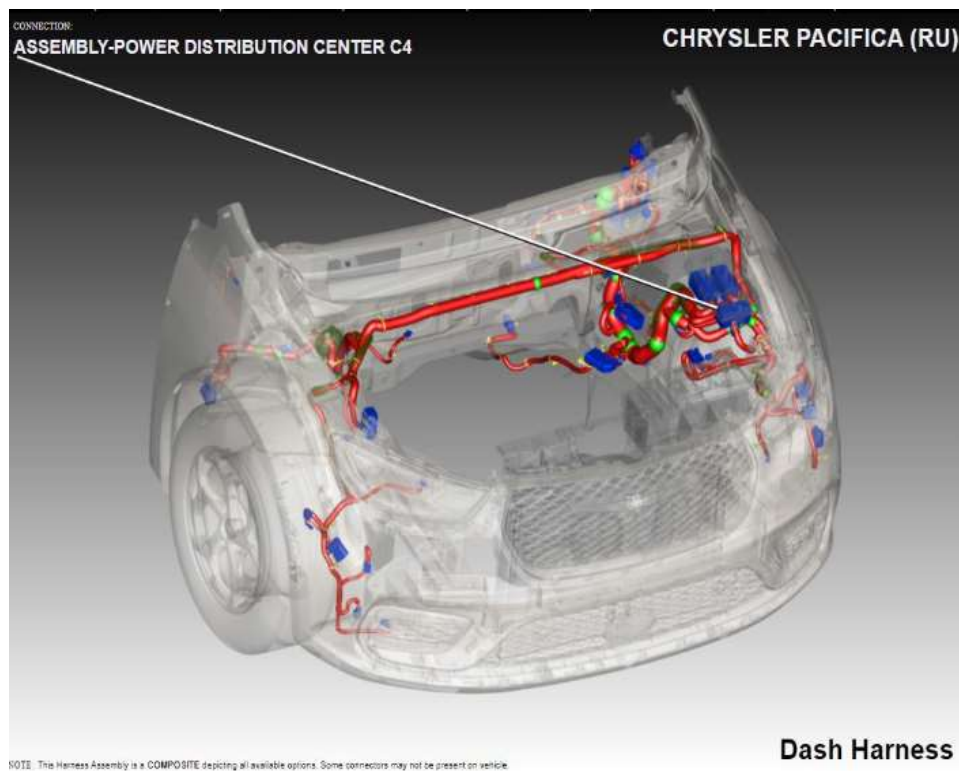
Fig 1

Owner Complaint/Technician Observation: Owner complains that the vehicle is not cranking when attempting to start. Technician has observed this condition.

Repair Procedure: Inspect the C4 black 62-way connector at the PDC, Pin 4 T750 circuit YE/GY. T750 circuit has no power during the crank request. Secure the T750 circuit at the C4 connector and or replace with a terminal as needed (full repair kit 68396626AA) Fig 1, 2.
