STAR ONLINE PUBLICATION

Case Number: S2008000132 - Rev. C

Release Date: March 2022

Symptom/Vehicle Issue: Malfunction Indicator Lamp Illuminated. U11E9 Lost Communication With AGS. Ambient Air Temp Incorrectly Displayed. P0070 And P0073 Set For Ambient Air Temp Sensor

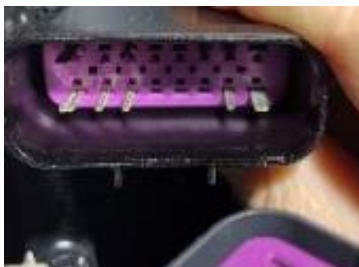
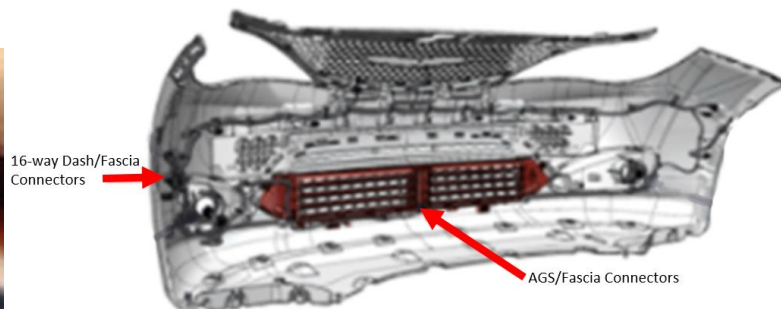
1. Inspect the wiring near the 16-way XY101A Dash to Fascia Connector for nicks and cuts. Also disconnect the connector and inspect for corrosion and terminal pushout.

1. If corrosion, damage, or terminal pushout is present at the XY101A connector. Use connector kit 68497543AA to repair the 16-way Dash side connector and replace the Fascia side harness. A connector repair kit 68500834AA for the fascia side connector is also available. But due to the various possible issues described, fascia harness replacement is recommended.

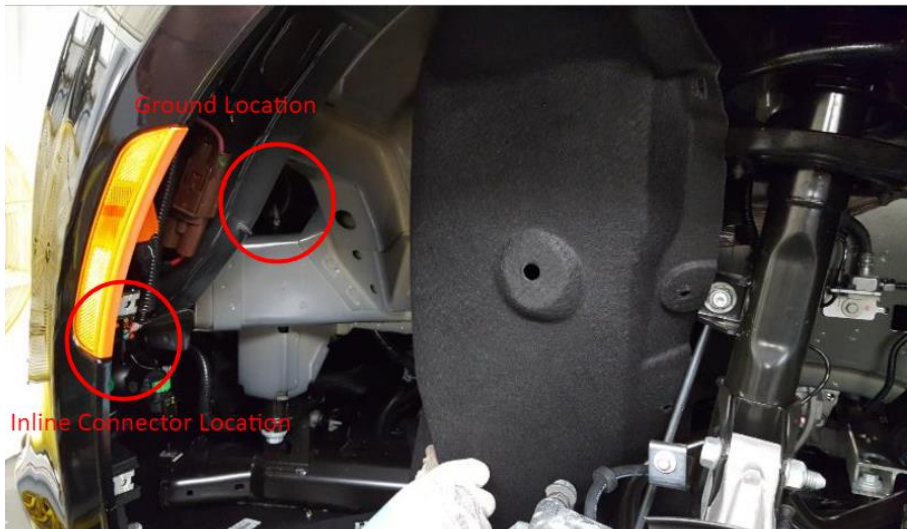
Ground and Inline Locations

2. The G917 ground located under the battery may be corroded creating high resistance. Water intrusion from the dash side connector could migrate to the ground, gather, and cause corrosion behind the sealed ground eyelet.

2. If the G917 ground is corroded and high resistance is measured. The ground circuit should be repaired using best practices.
3. If corrosion is present in the AGS connector, replace the AGS. **Do not add dielectric grease to the AGS/fascia connectors.** If corrosion is present in the fascia connector, repair it using connector kit 68396618AB or replace the harness as necessary.
4. If water intrusion is found in either of the Fog or Front Side Marker Lamp housings, replace the Fog and/or Side Marker assemblies. If water intrusion is found in any of the connectors. Use wiring diagrams or Mopar connector repair website to locate the correct connector repair kit (varies by model year).

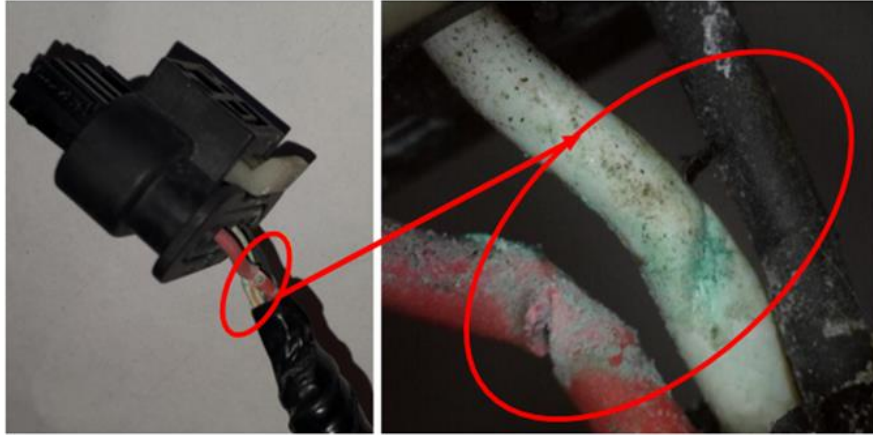
3. Disconnect the AGS to fascia/dash connectors and inspect for damage and corrosion.

Active Grill Shutter Connection Damage/Corrosion

Note: If the corrosion or damage is found on the wiring harness, do not replace the mating connector on the AGS side. Repair wiring and retest.
