NUMBER: 23-008-22

Second Row Seat Backs Not Folding Flat

2022 (WS) Grand Wagoneer/Wagoneer

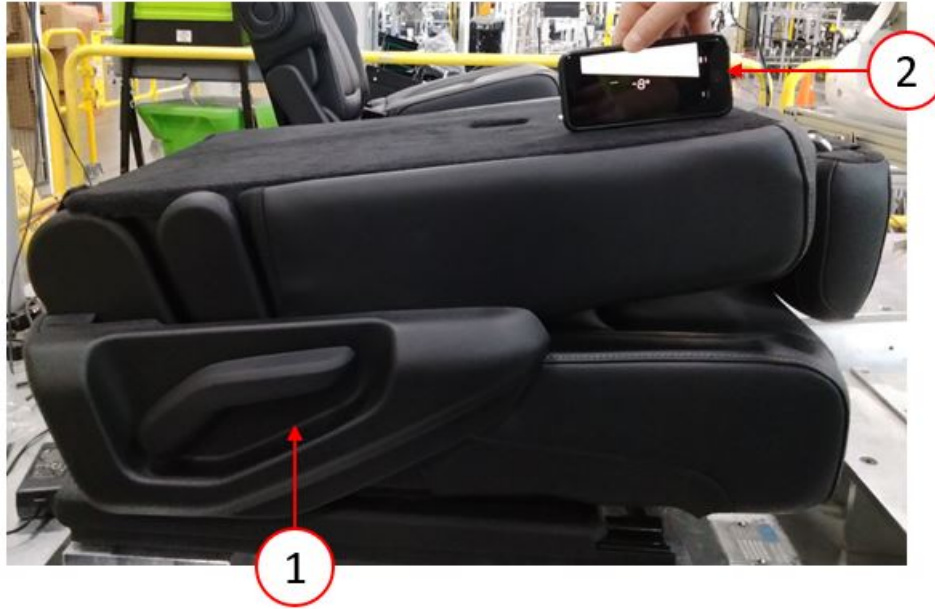
Fig. 1
Seat Folded Flat

2. Using a cell phone with a level gauge App, check the angle of the seat back. (Fig. 1) .

3. Is the angle on the seat back greater than 8 degrees?
- YES >>> Proceed to [Step 4](#).
 - NO >>> This bulletin does not apply.
4. Rotate seat back forward about 45 degrees Then disengage the J retainers on the front inboard and outboard sides of the cushion (Fig. 2) .
