NUMBER: 18-055-22

Flash: Powertrain Control Module (PCM) Updates

2020	(DD)	RAM 3500 Cab Chassis
2020	(DP)	RAM 4500/5500 Cab Chassis

NOTE: This bulletin applies to vehicles equipped with a 6.7L I6 Cummins Turbo Diesel Engine (Sales Code ETN).

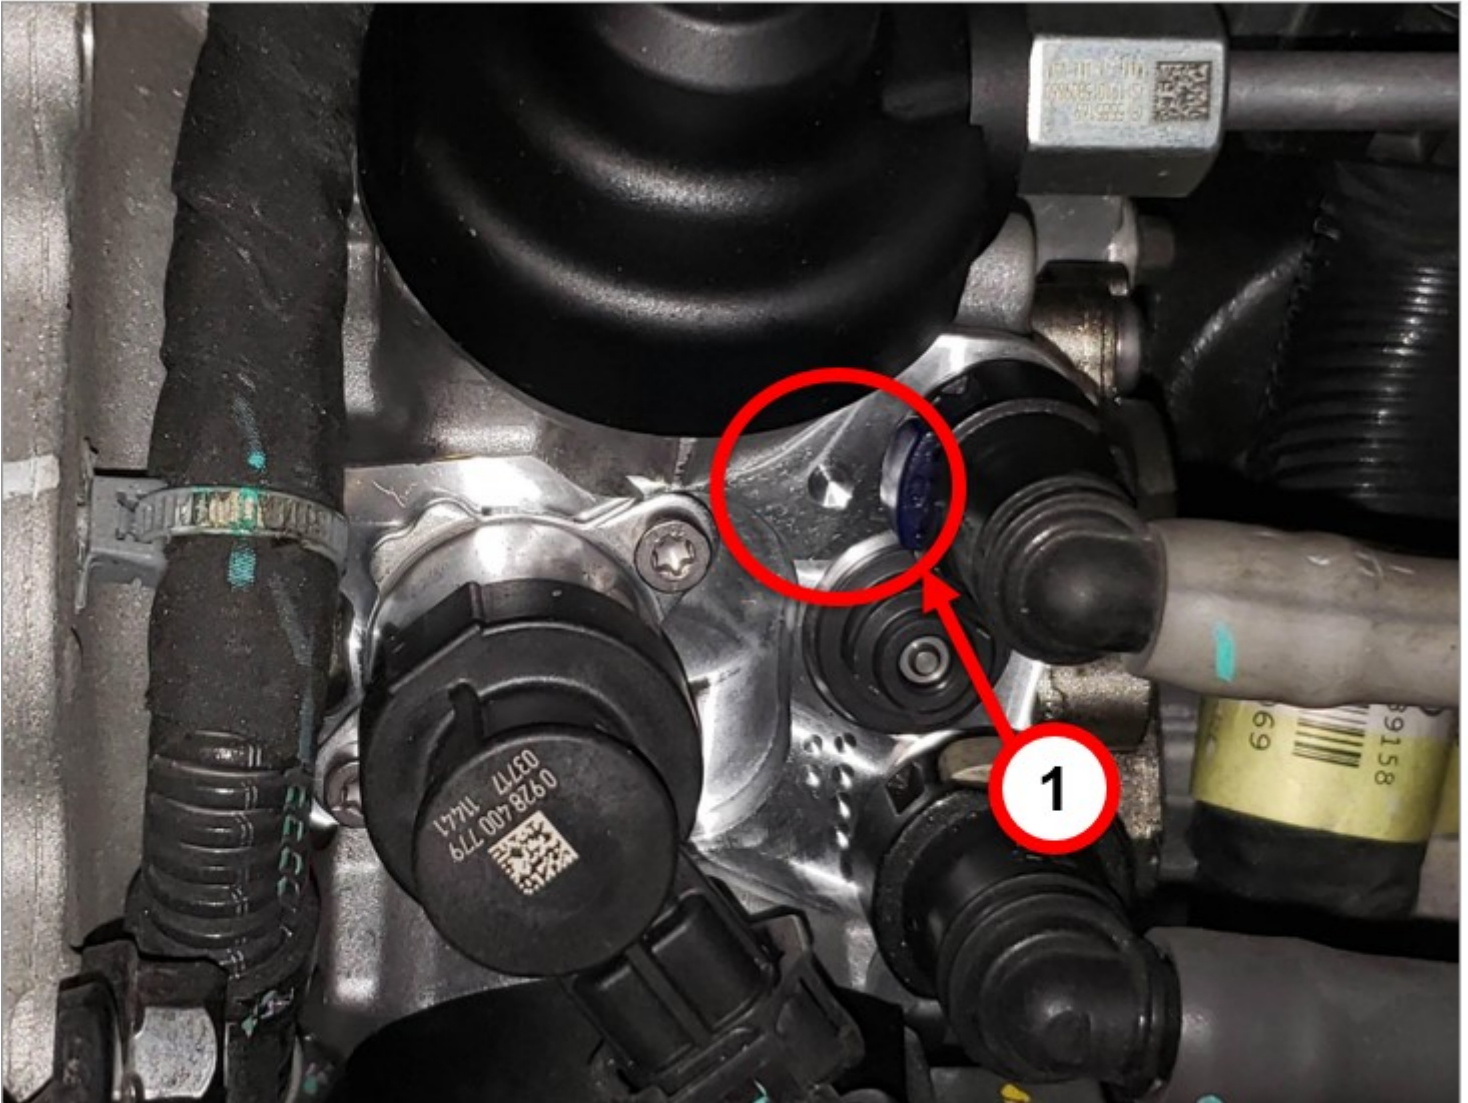
Fig. 1
New Style Symmetrical Cam Design Pump

1. Inspect the fuel injection pump to see which pump the vehicle has:
 - Vehicles with the new style Symmetrical Cam design pump will have one large single dot embossed in the pump housing (Fig. 1) .
 - For vehicles equipped with a Symmetrical Cam pump, choose the calibration labeled Symmetric Cam, or Sym Cam.

1 - One large Single Dot on Housing.

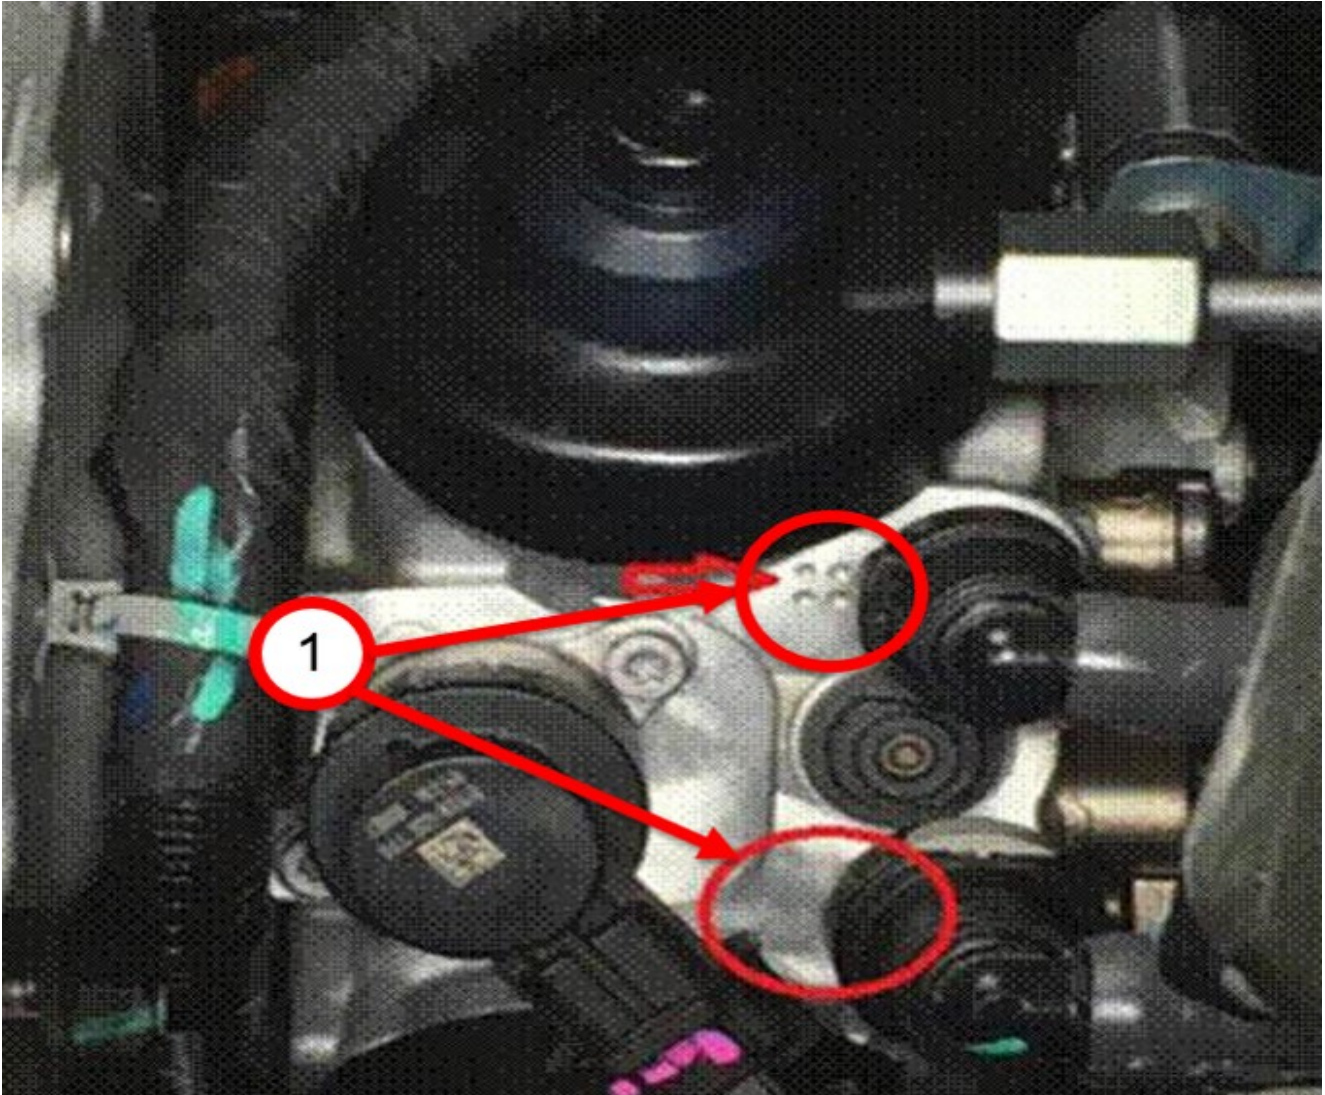
Fig. 2

- Vehicles with the old style Asymmetrical Cam design will have multiple small dots or no dots embossed in the pump housing (Fig. 2) .
- For vehicles with an Asymmetrical Cam pump, choose the calibration labeled Asymmetric Cam or Asym Cam.

Old Style Asymmetrical Cam Design Pump

1 - Multiple Small Dots or No Dots Embossed In The Pump Housing.
