**NUMBER:** 14-004-22 REV. A

Updated Fuel Filler Cap and Fuel Filler Tube

2021 (JL) Jeep Wrangler

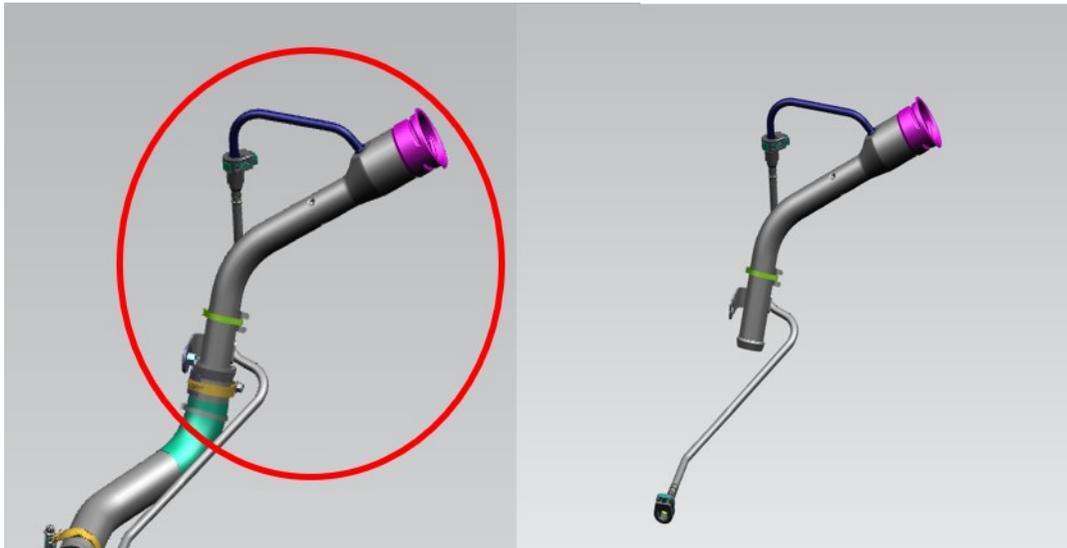
**Fig. 1**  
**Upper Fuel Fill Tube**

**NOTE: The above condition is caused from an air leak through the fuel filler cap and fuel filler neck seal.**

1. Remove and discard the fuel filler cap from the upper filler tube (Fig. 1) .
2. Install the new fuel filler cap on the filler tube (Fig. 1) .
