Global Telematics Box Module (TBM2) Flash Over The Air Software Version Updates

2022 (MP) Jeep Compass

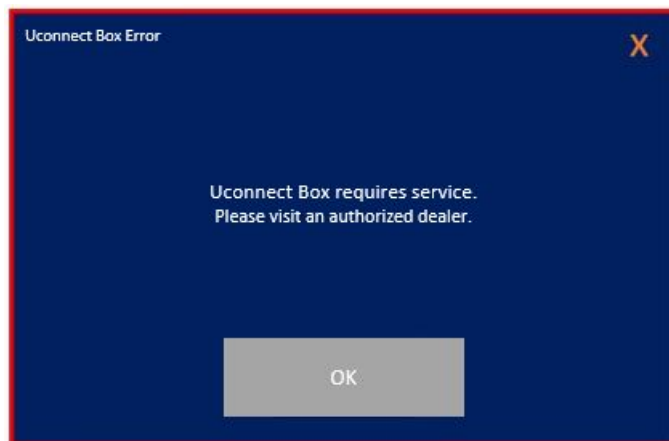
- Message displayed on the radio screen, "Uconnect Box requires service. Please visit an authorized dealer." (Fig. 1) .

**Fig. 1**  
**Error Message**

- B1570-93 - USB Communication-No Operation.
