NUMBER: 18-061-22

Incorrectly Assembled Purge Flow Tube Inside Tube Elbow

2021 - 2022 (WL) Jeep Grand Cherokee

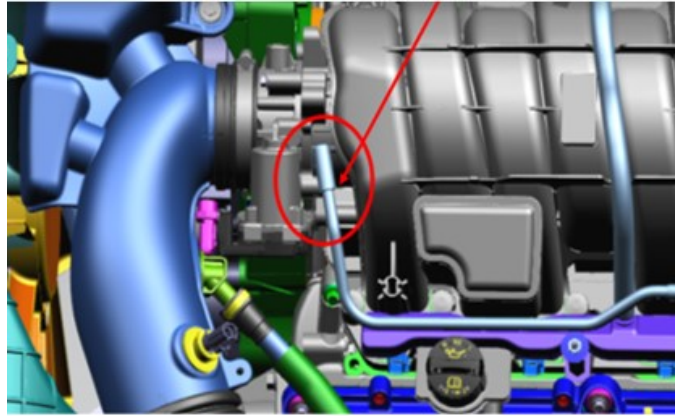
Fig. 1
Purge Hose at Intake Manifold

1. Inspect the purge tube at the elbow on the intake manifold. (Fig. 1)

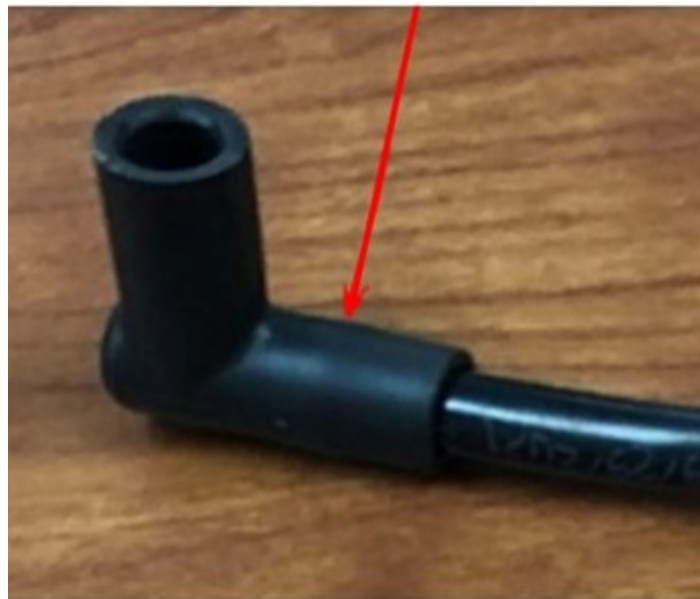
1. Is the purge tube pushed too far into the elbow (Fig. 2) (Fig. 3) ?

Fig. 2
Purge Tube Inserted Too Far

2. Pull the nylon tube from the rubber elbow until the bead is positioned at the edge of the elbow. Ensure that the elbow is seated properly at the intake manifold port. (Fig. 4) , (Fig. 5)

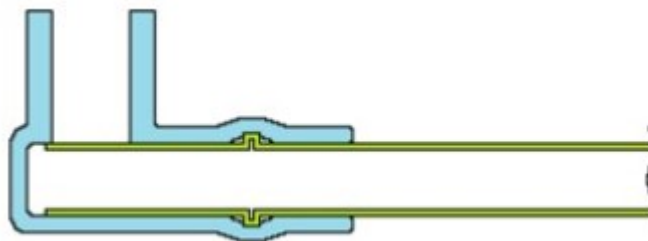
Fig. 3
Incorrectly Installed Purge Tube Into Elbow

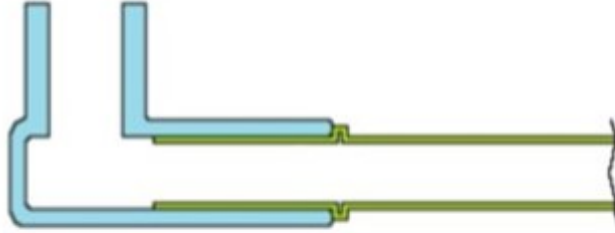
Fig. 4
Purge Tube Correct Crosssection

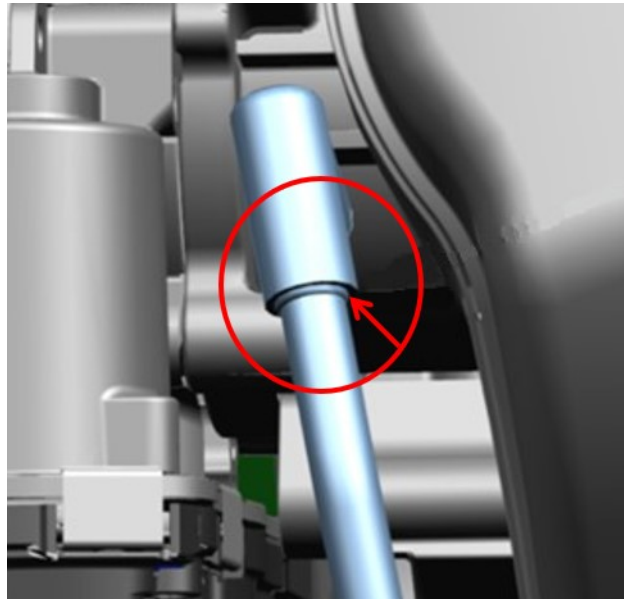
Fig. 5
Purge Stop Bead At Elbow
