NUMBER: 23-014-22

Driver Side Seat incorrect fasteners

2021 - 2022 (DT) Ram 1500 Pickup

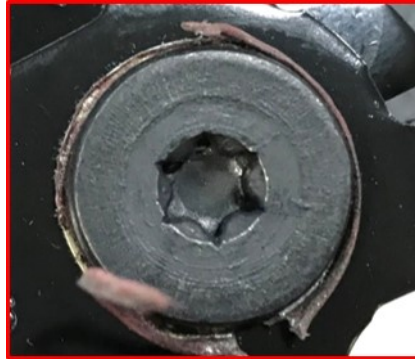
1. Does the driver's seat side feel loose and/or make noises?
 - YES>>> Proceed to [Step 2](#) of the Repair Procedure.
 - NO>>> This bulletin has been completed, use inspect LOP (23-13-36-9G) to close the active RSU.
2. Adjust Driver's seat height full upwards and full rearward for best visual clearance.
3. Verify correct bolt in three locations on seat frame. The use of a flashlight, mirror and/or camera phone will help to inspect the front inboard bolt head due to obstruction from the center console. The incorrect fasteners will have a flat surface with no taper on the outside diameter. Also will have no numbering or other markings. ([Fig. 1](#)) , ([Fig. 2](#)) , ([Fig. 3](#)) , ([Fig. 4](#)) ,

Fig. 1
Incorrect Bolt

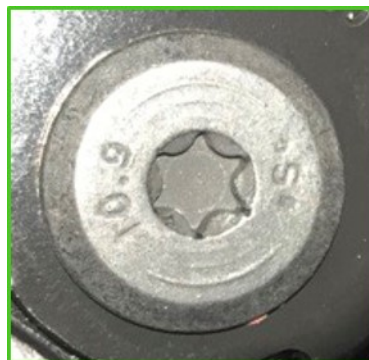
Fig. 2
Correct Bolt

10. Install new bolts. Tighten to 28 N·m (21 ft. lbs.)
11. Apply masking tape to protect the driver's side center console lower trim panel.
12. Remove incorrect track bolt with a T45 bit.
13. Remove threadlocker debris from incorrect bolt. The incorrect bolt can be used to remove debris within the threads by reinstalling and removing multiple times. (Fig. 5)
14. Apply grease to all surfaces of red bushing inside bracket. This applies to all bushings where the wrong track bolt is present. (Fig. 6)
15. Ensure shoulder of bolt is guided through inside of bushing. (Fig. 7)
16. Install new bolt. Tighten to 28 N·m (21 ft. lbs.)

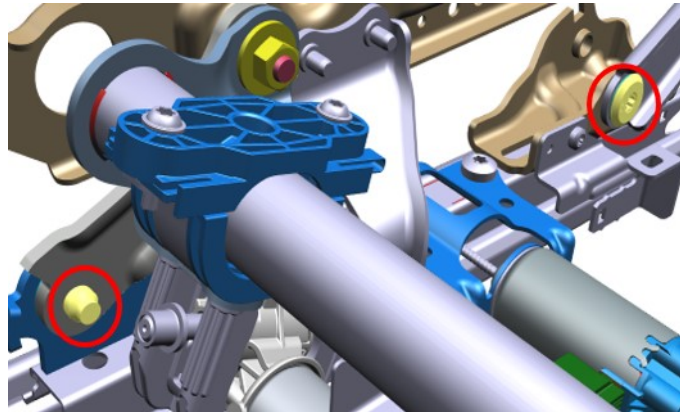
Fig. 3
Bolt locations

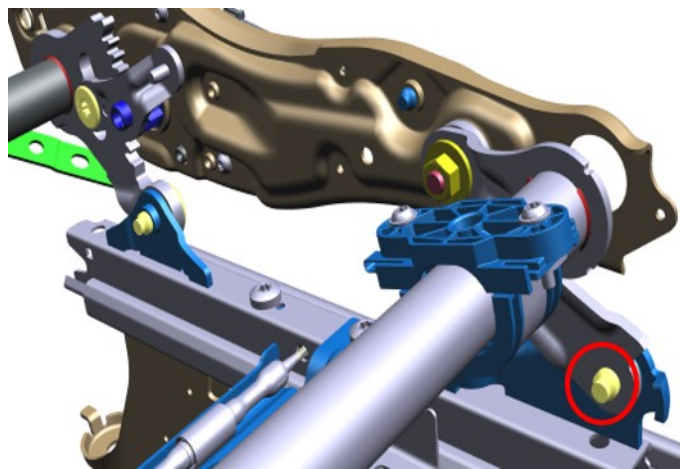
Fig. 4
Bolt Location

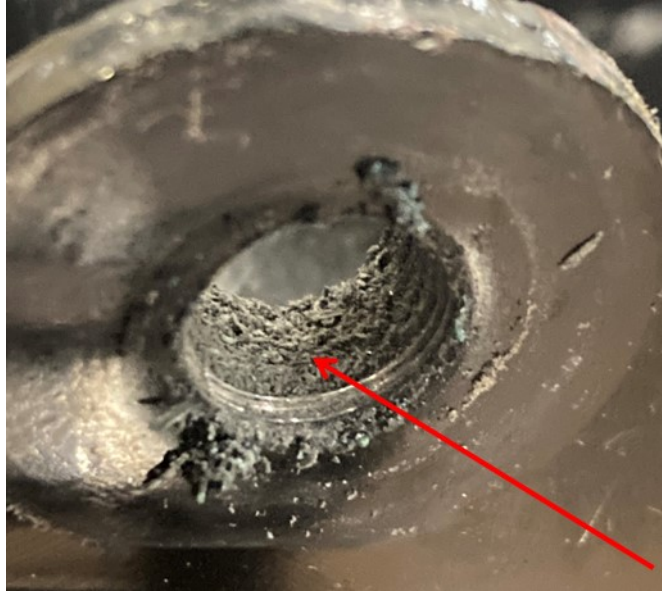
Fig. 5
Threadlocker

7. Remove threadlocker debris from incorrect bolt. The incorrect bolt can be used to remove debris within the threads by reinstalling and removing multiple times. ([Fig. 5](#))

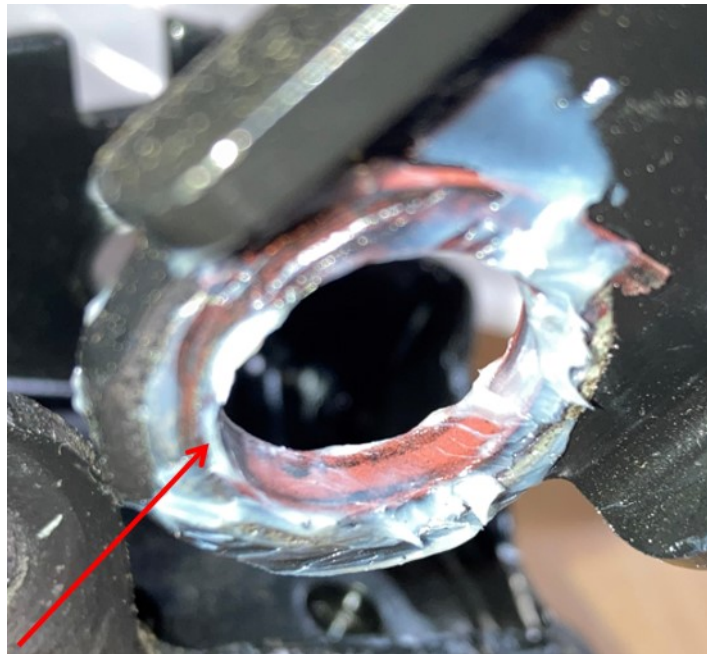
Fig. 6
Apply Grease

8. Apply grease to all surfaces of red bushing inside bracket. This applies to all bushings where the wrong track bolt is present. (Fig. 6)

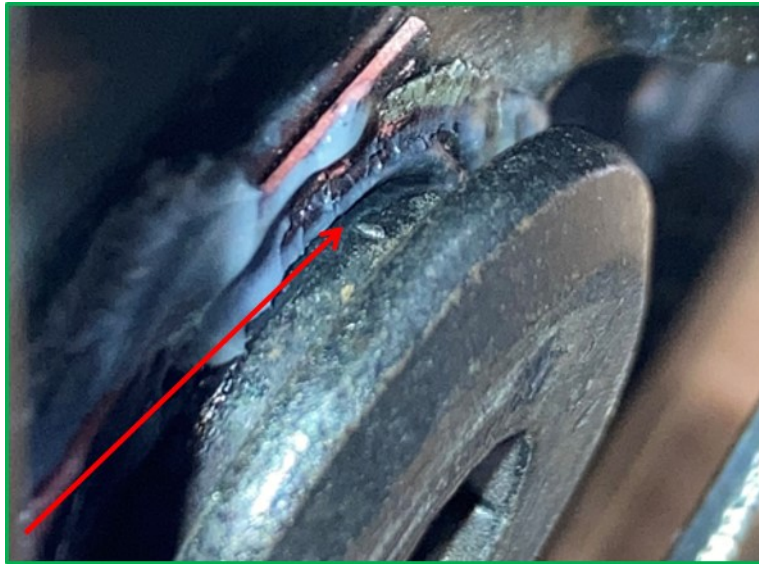
Fig. 7
Bolt shoulder in hole

9. Ensure shoulder of bolt is guided through inside of bushing. (Fig. 7)
