NUMBER: 08-072-22

Race Cool Down Feature Inoperative

This bulletin involves installing a hood latch, adding a hood latch switch jumper harness and a Body Control Module (BCM) Reconfiguration.

2021 (DT) RAM 1500 Pickup

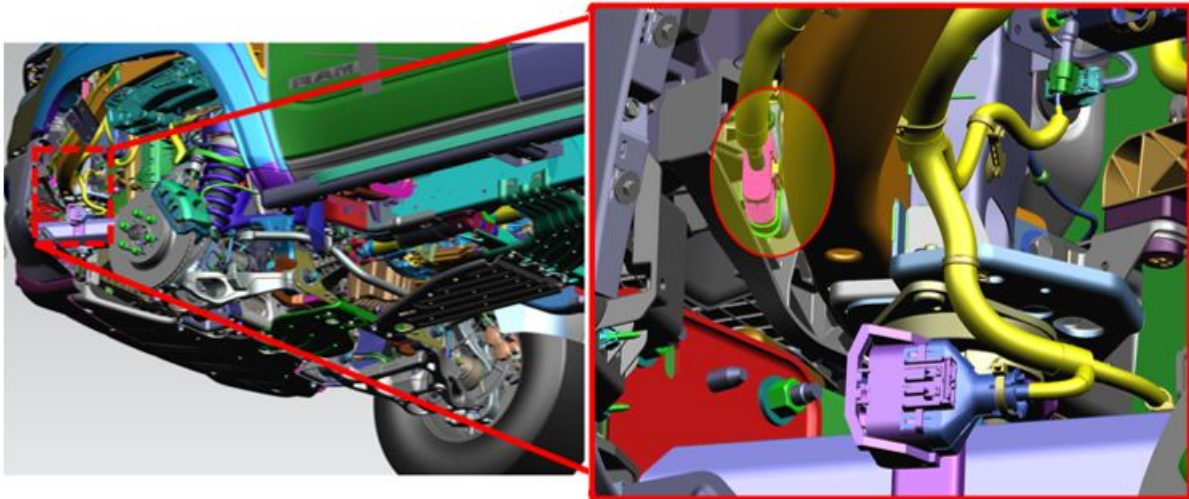
Fig. 1

Location of Connector XY100A

1. Replace the hood latch switch. Refer to the detailed procedures available in DealerCONNECT > Service Library> under: 23 - Body / Hood / Latch, Hood / Removal and Installation.
2. Remove the left front tire and splash shield to gain easy excess to main harness connector XY110A (Fig. 1) .

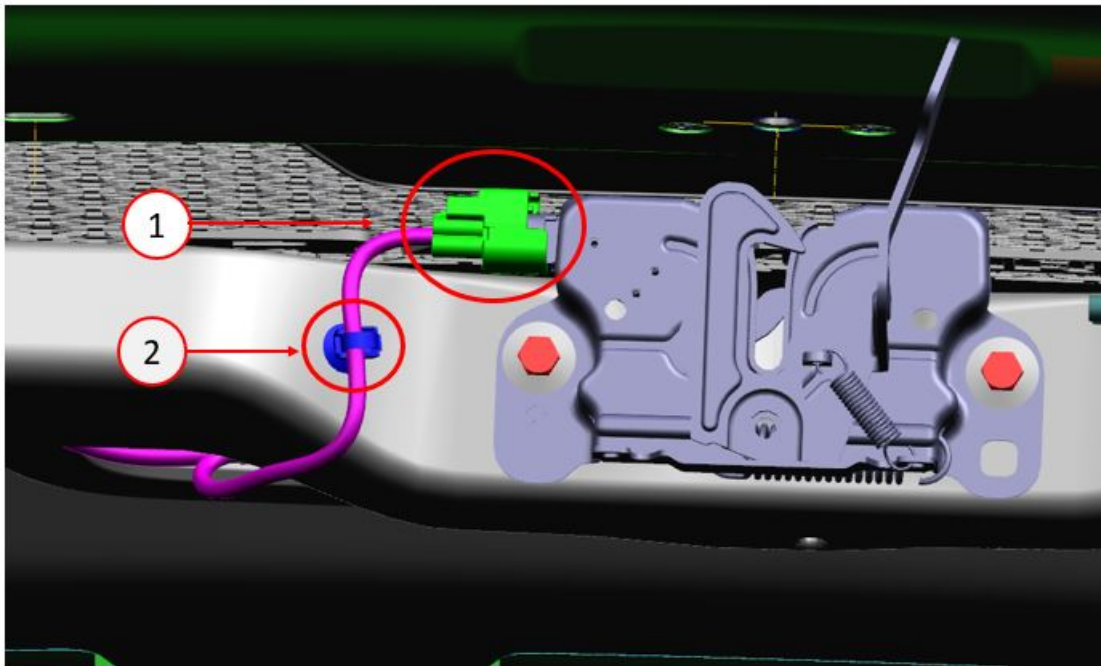
Fig. 2
Hood Latch and Harness

- 1 - Latch Connector
- 2 - Wire Harness Clip

5. Secure the jumper harness to the headlamp harness using Tesa tape (51036) or equivalent. Install a wire harness clip next to the latch (Fig. 2).

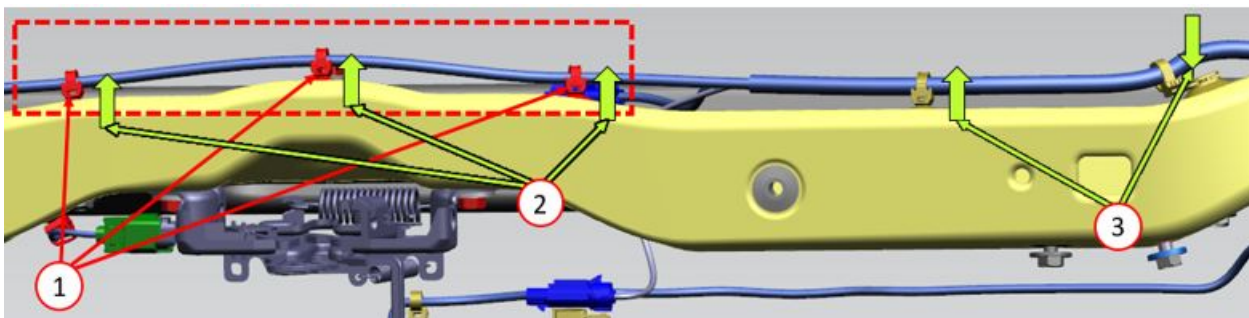
Fig. 3
Back View of Crossmember

- 1 - Existing Main Harness Xmas Tree clips
- 2 - Location for New Tie Strap
- 3 - Location for New Tie Strap

NOTE: If the three Xmas tree clips are missing in figure (Fig. 3) call out number one, use the three new clips in the jumper harness kit to attach the jumper harness.

7. Add a tie straps to hold the jumper harness to the main harness next to the existing Xmas tree clips (Fig. 2).

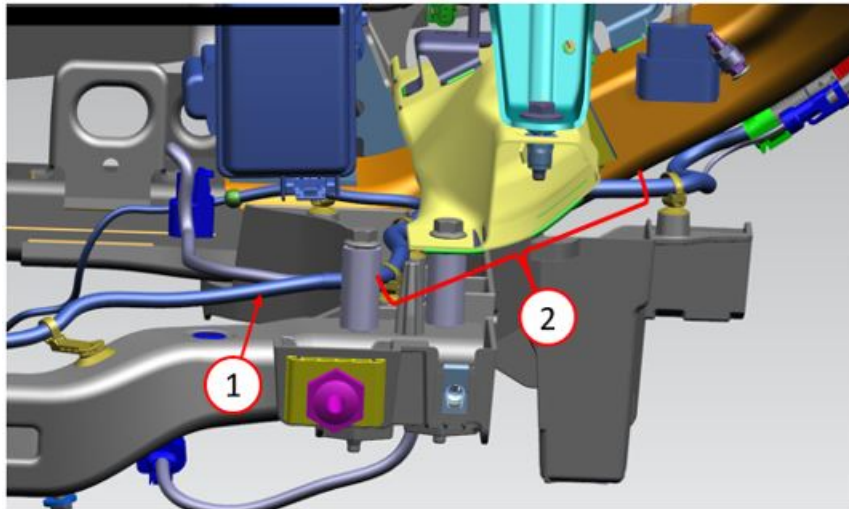
Fig. 4
Run Harness Behind Radiator Support

- 1 - Location for New Tie Strap on Main Harness
2 - Run Jumper Harness Behind Radiator Support
-

8. Add tie strap to hold jumper harness to main harness and run the jumper harness behind the radiator support (Fig. 4) .

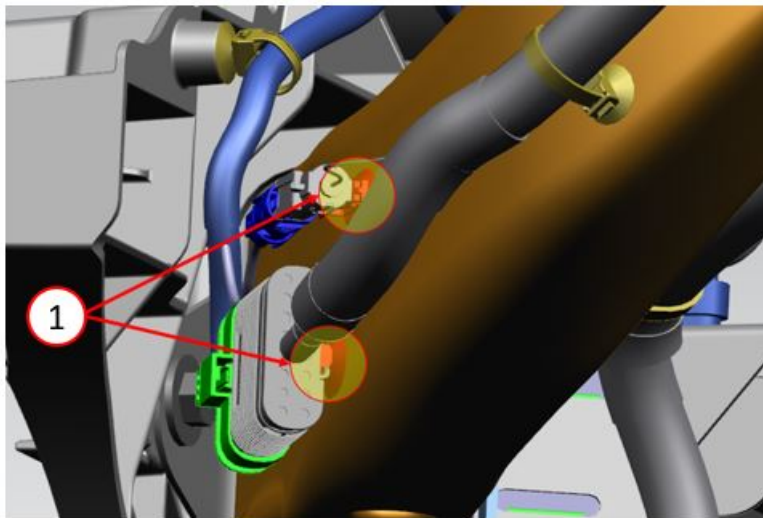
Fig. 5
Connector Clip/Retainer Location

- 1 - Connector Clips
-

9. Carefully unclip both connections from cross member and insert the loose pins from the jumper harness in to connector XY100A (Fig. 5) .
