STAR ONLINE PUBLICATION

Case Number: S1823000030 Rev A.

Release Date: August 2022

Symptom/Vehicle Issue: Buzz Squeak Noise From Steering Column Area While Turning Steering Wheel

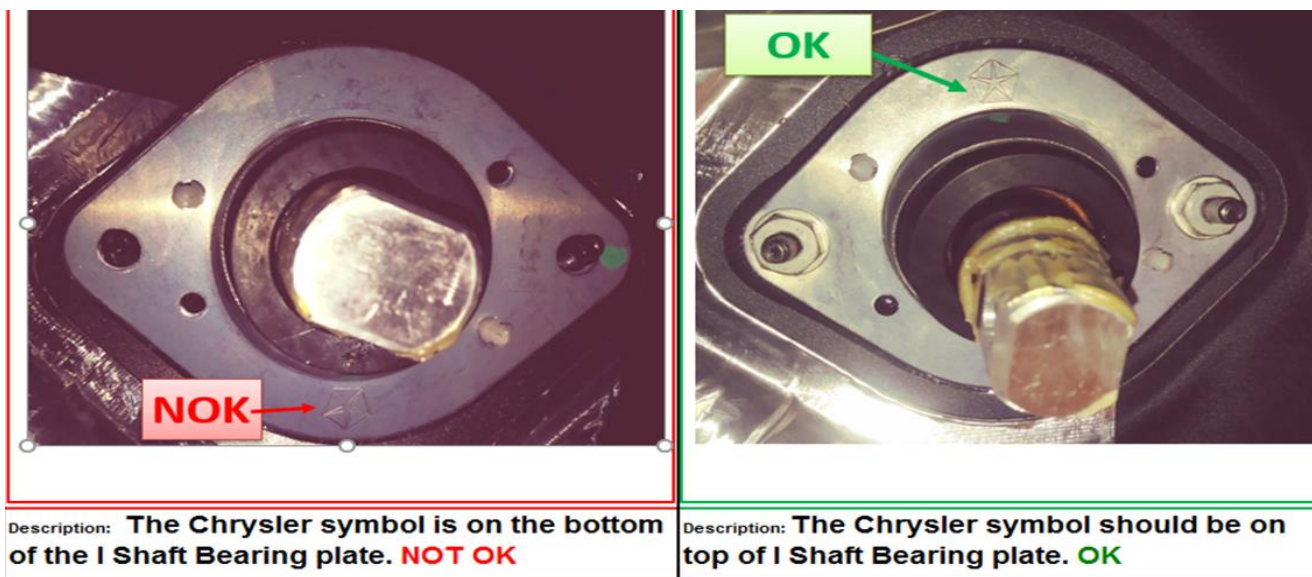
Fig 1

Discussion: The steering intermediate shaft bearing plate is a directional part and if installed in the incorrect orientation could cause noise from the steering intermediate shaft. See the below images for proper orientation/ installation of the intermediate shaft bearing. Chrysler Pentastar emblem must be at the 12 o'clock position (Fig 1). Newer versions of the plate will have "TOP" stamped into the metal (Fig 2).

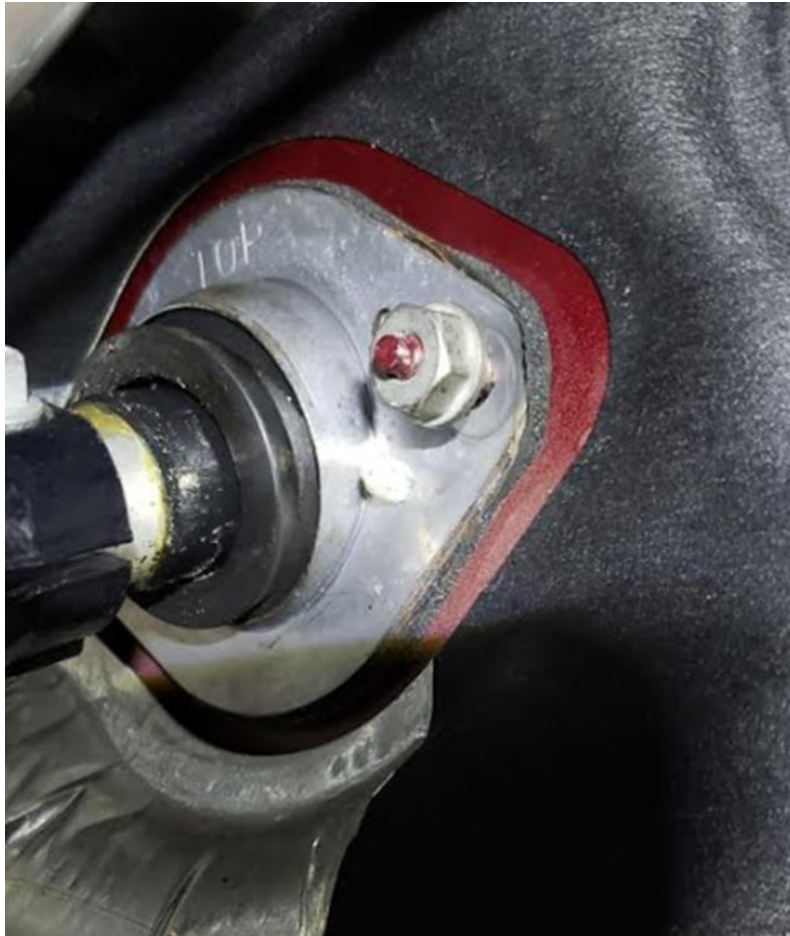
Fig 2. Late design "TOP".
