STAR ONLINE PUBLICATION

Case Number: S2208000150

Symptom/Vehicle Issue: Malfunction Indicator Lamp (MIL) On, "Check Fuel Cap" Message

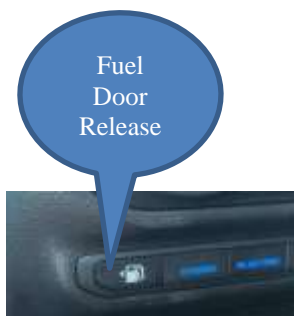
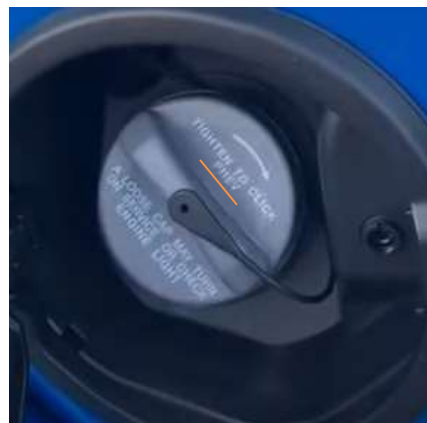
Discussion: Verify the vehicle has no applicable Technical Service Bulletins (TSB's) or other related field service actions. Inspect the fuel filler cap, all PHEV vehicles will have a grey fuel fill cap with "PHEV" labelled on the cap face.
