STAR ONLINE PUBLICATION

Case Number: S1923000052 Rev. A

Release Date: August 2022

Symptom/Vehicle Issue: Wind Noise From Lower Center Windshield Area At Highway Speed

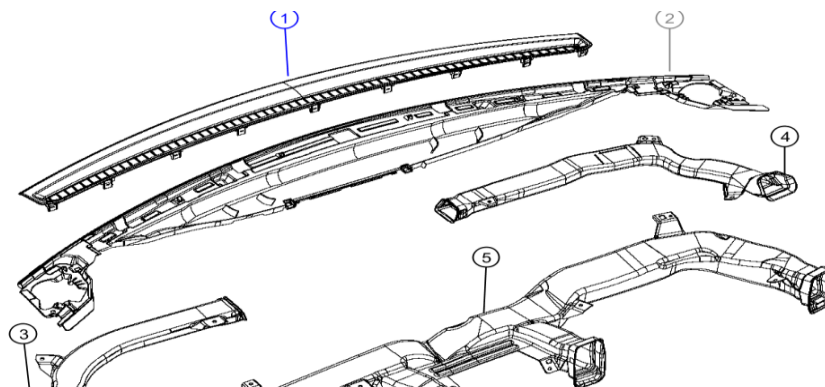
Discussion: Isolate the noise location with chassis ears, stethoscope or a simple stethoscope made from a 3' piece of heater hose held to your ear and the other moved to source the noise location. If the noise is around the upper dash windshield, remove the trim to inspect the bolt locations shown below. A missing fastener can cause wind noise.

To access the area using a trim stick remove item #1 Cowl Top Cap.

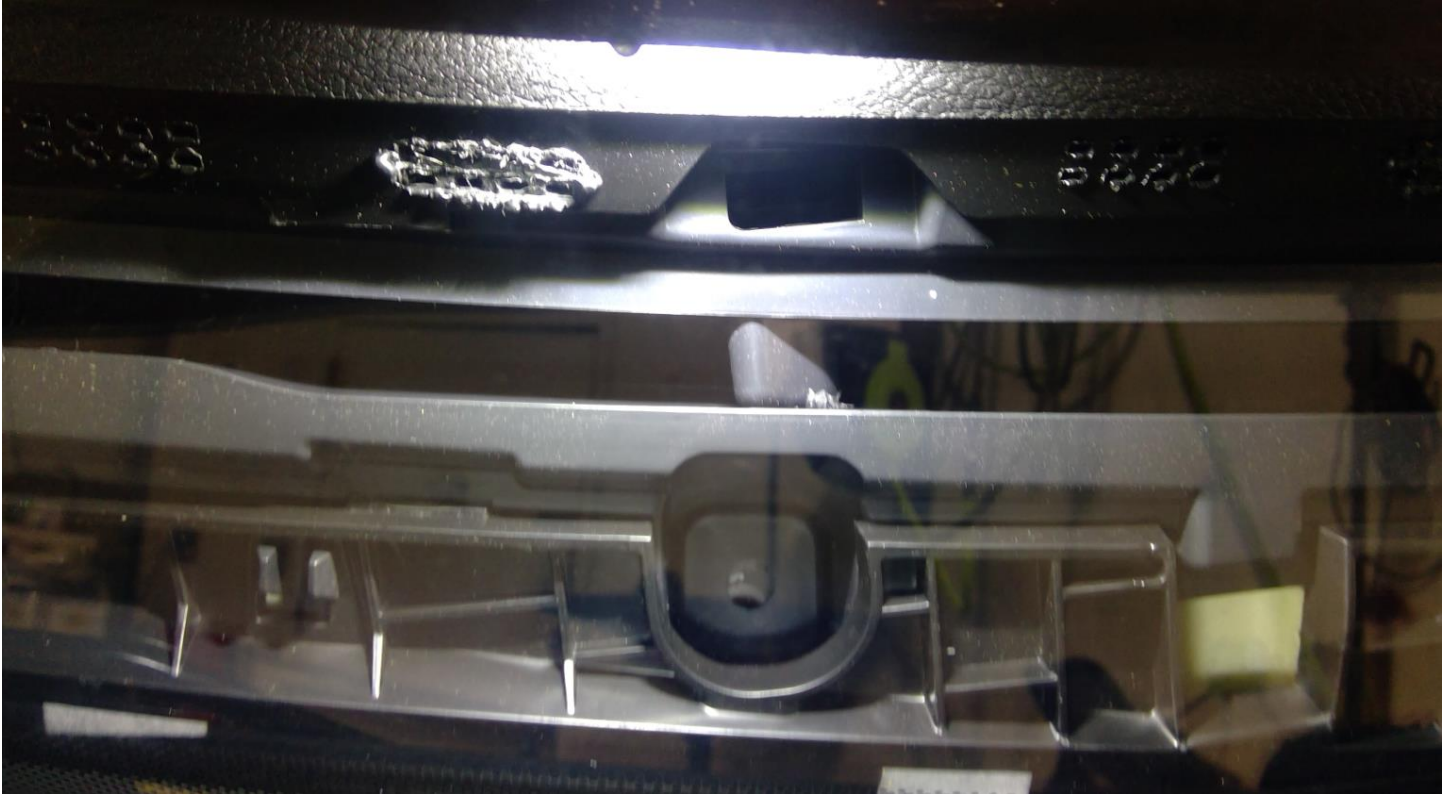
Fastener part number 06100567 attaches the upper dash to the body at the windshield.

Verification: Test drive to confirm repair.
