STAR ONLINE PUBLICATION

Case Number: S228A000022

Release Date: August 2022

Symptom/Vehicle Issue: Connected Service Requires Service Message

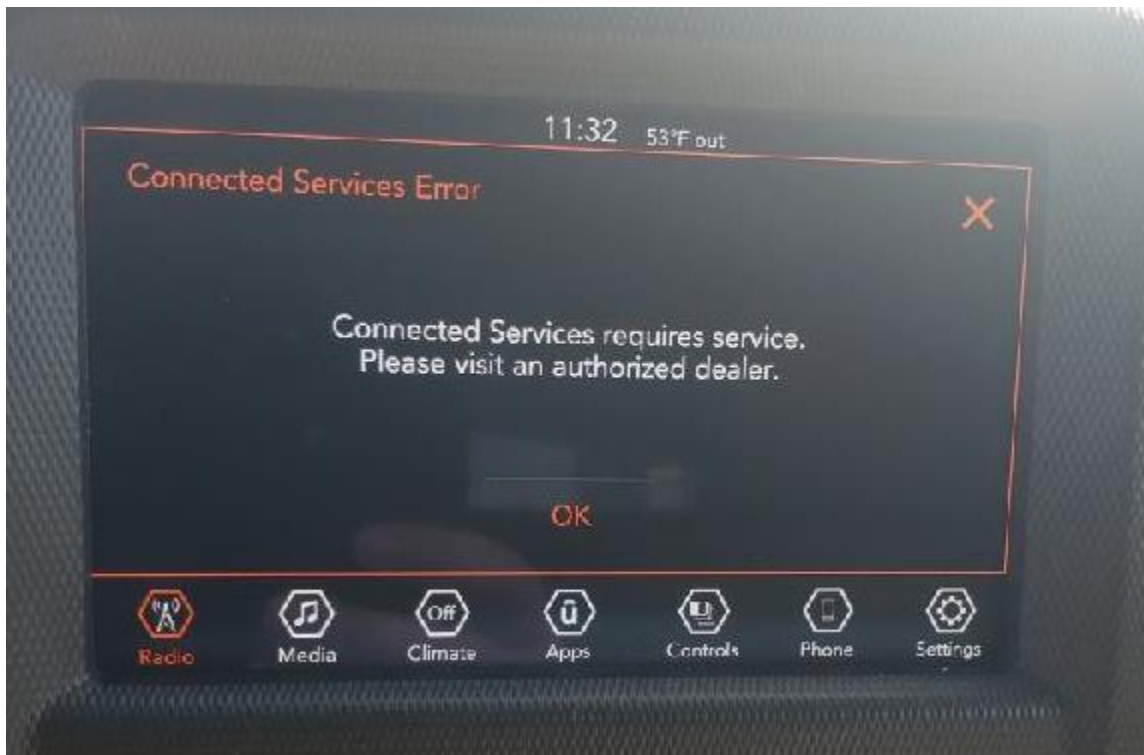
Fig 1 Error Message

Customers might receive a message on the radio “Connected Service requires service. Please visit an authorized dealer” when vehicle starts, and connectivity feature is inoperable.

The technician will see this message right after the vehicle is switched to customer mode or a new Telematics Box Module (TBM) is installed.

1. Run a Configuration and Scan report.
2. Verify if there is any TBM related Diagnostic Trouble Codes (DTC).
3. If a TBM DTC is active, the Connected service message will appear. Please repair any DTC issues per normal diagnostics repair procedures in Service Library.
4. Perform TBM ECU reset and clear the DTC if required.
5. If there is no TBM related DTC active, the popup message maybe triggered due to missing security certificate.
6. Good AT&T or Rogers network coverage and good GPS signals are required in order to get TBM connect to the server.

7. To complete connectivity vin lock, the vehicle needs to have over 5 miles (or 5 km) on it. Please take a short drive if needed.
8. Leave the vehicle ignition on for 15 to 20 minutes. Then cycle ignition off and on multiple times. Verify if the popup message disappears.
