## STAR ONLINE PUBLICATION

**Case Number:** S2223000064

**Symptom/Vehicle Issue:** Park Assist Warning Displayed On Cluster After Recent Service Repair.

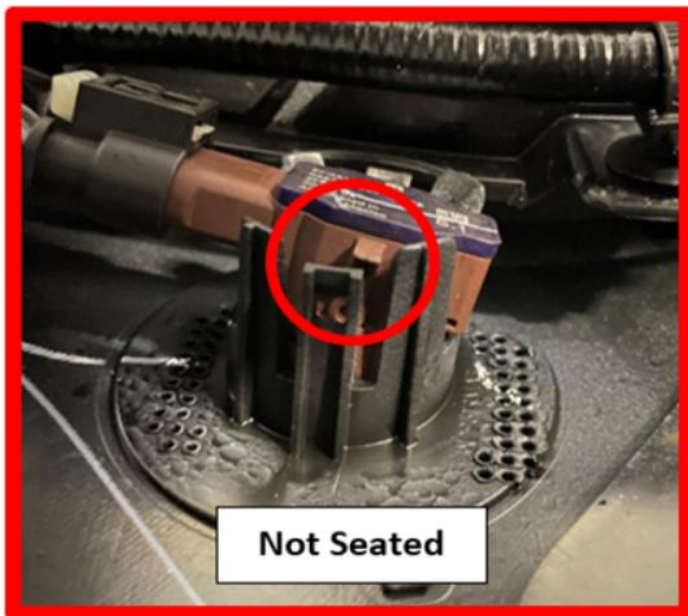
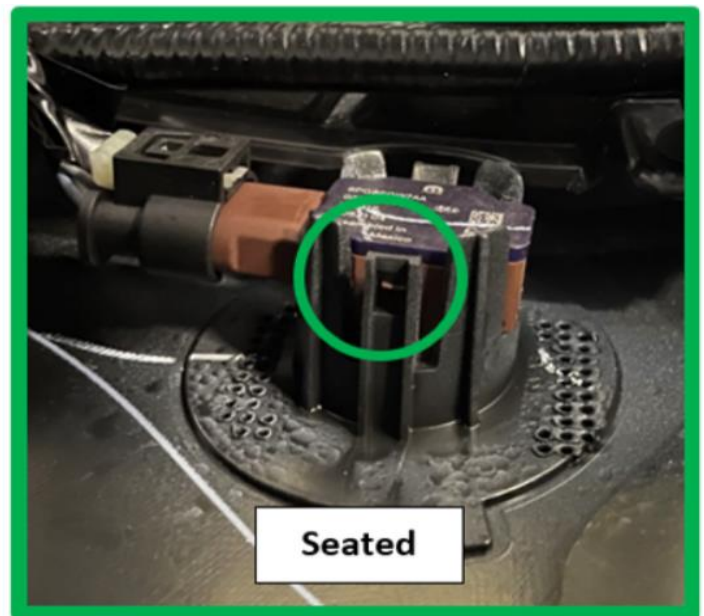
**Discussion:** Message of “Service Park assist” may display on the Instrument Cluster message center. Inspect the Front and Rear Fascia sensors fitment. Verify the clips are engaged and locking tabs are fully seated. See the below images.
