Revision (1) August 2022

Emissions Recall U90 Catalyst Efficiency

About **155,288** of the above vehicles may exceed tailpipe emission standards due to a loss of catalyst CO/NOx conversion efficiency resulting from the catalyst operating at high temperatures.

Install a new catalyst and reprogram the Powertrain Control Module (PCM) and Transmission Control Module (TCM) with the latest software.

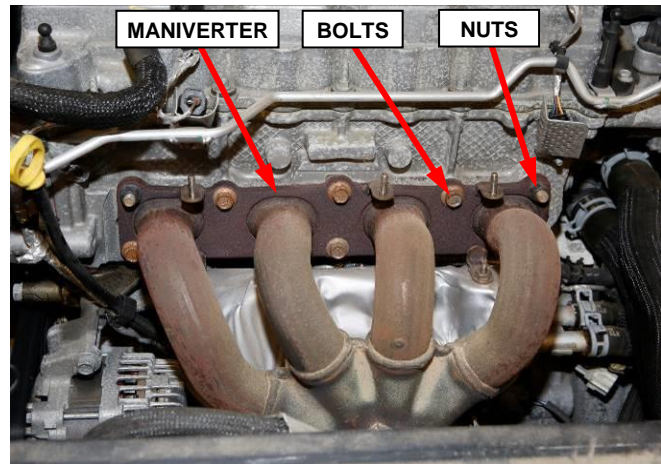
Figure 12 – Manivertter to Engine

CAUTION: Use care when removing the bolts that secure the manivertter to the engine cylinder head. Aluminum cylinder head fastener threads are susceptible to damage if the bolts are not removed with care. Use hand tools **ONLY**.

19. Remove the fasteners, six bolts and two nuts, securing the manivertter to the engine cylinder head (Figure 12).

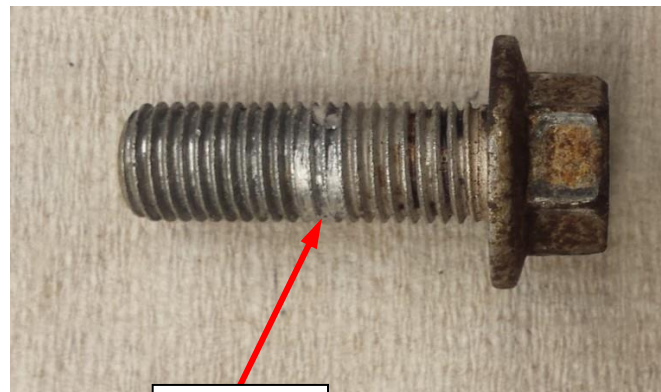
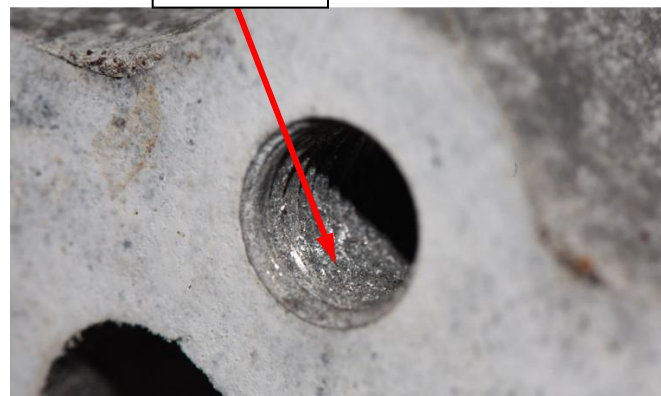
Figure 13 – Inspect for Thread Loss

NOTE: Pay attention to the bolts for signs of thread loss or bolt breakage as they are removed and note which hole they came from (Figure 13).

20. Inspect the bolts and bolt holes for any signs of thread loss then **DISCARD** the bolts (Figure 11).

- If bolt holes do not show signs of thread loss, proceed to **Step 23**.
- If bolt holes show signs of thread loss, continue with **Step 21**.
- If a bolt is broken off in the hole, proceed to **Step 22**.

21. If thread loss is suspected, use compressed air to remove any debris from the suspect bolt hole. With the old maniverter and gasket still in place on the engine head, install a **NEW** exhaust manifold bolt in the suspect hole and tighten the bolt to 34 N·m (25 ft. lbs.) to determine if proper torque can be achieved.

- If the bolt is able to be tightened to 34 N·m (25 ft. lbs.), no further action is required. Remove the bolt and proceed to **Step 23**.
 - If the bolt hole threads are stripped allowing the bolt to rotate, unable to achieve proper torque, remove the bolt and continue with **Step 22**.

22. For stripped hole(s) or broken bolt(s), submit a collateral damage claim to obtain authorization for installing a helicoil in the damaged hole(s). Remove the maniverter and gasket following **Steps 23 - 25**. Then use the special tool **2073500090 - Kit, Cylinder Head Thread Repair - 2.4L MAIR** to perform the helicoil thread repair operation by following the service instructions published in **DealerCONNECT / Service Library / Engine, 2.4L Multiair / Standard Procedure / Exhaust Manifold Fastener Hole Repair**. After the damaged bolt hole(s) have been repaired with helicoil(s), proceed with **Step 26**.
