**NUMBER:** 08-156-22

Video Routing Module Inoperative

This bulletin involves reprogramming the Video Routing Module (VRM) with the latest available software.

2022 (WS) Grand Wagoneer/Wagoneer

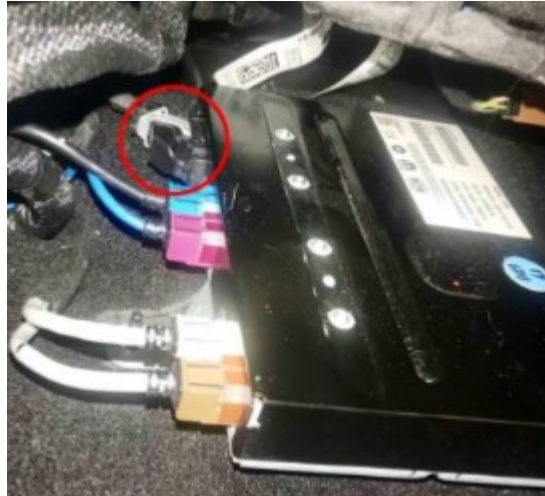
**Fig. 1**  
**VRM (C1) connector**

- VRM not turning on during ignition cycle.

**NOTE: If VRM is not responsive on CAN bus or both rear screens are not turning on, turn off ignition, disconnect the Black (C1) VRM and reconnect. Verify screens turn on when ignition is turned back on.**

1. Are the Seatback Video Screens functional?
  - YES>>>Proceed to [Step 5](#).
  - NO>>> Proceed to [Step 2](#) .
2. With the vehicle off, move the front passenger seat all the way rearward, disconnect and reconnect the Black (C1) VRM harness connector from VRM found under the front passenger seat ([Fig. 1](#)) . Turn ignition back on.
