RYKER YAW Rate - SAS Sensor Faults - 137209

YAW rate sensor faults might be triggered due to loose front suspension components.

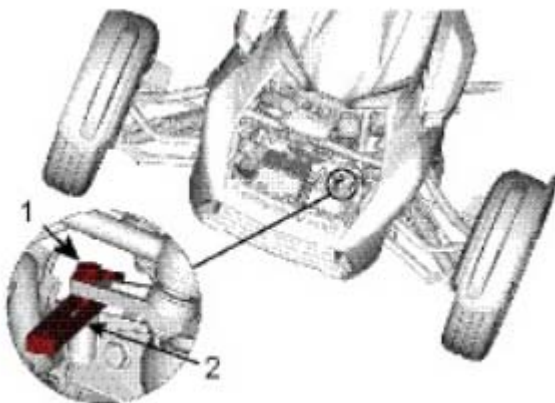
1. Alignment screw
2. Steering column spacer

- Simply lock the steering system on the LH pitman arm and do a SAS reset with BUDS2. Use Alignment screw (P/N 529 036 490)

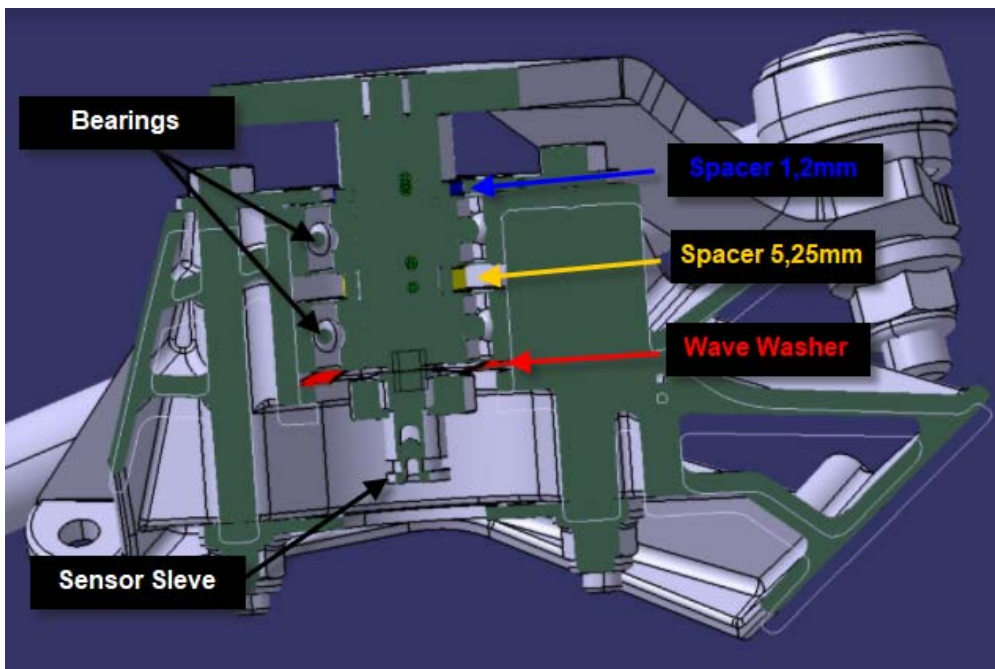
- If monitoring ID18 is there, replace the following;

Order kit P/N 219800513 (Note that this kit P/N is already installed from production on MY22 & up units)

- 1x 219800512 - Spacer 1.2 mm
- 1x 219800511 - Spacer 5.25 mm
- 2x 709402450 - Bearing
- 1x 219800510 - Wave washer
- 1x 709401526 - Sensor Sleeve
- 1x 487802246 - Generic Sheet

- Once parts are replaced, lock the steering system on the LH pitman arm and do a SAS reset with BUDS2. Use Alignment screw (P/N 529 036 490)

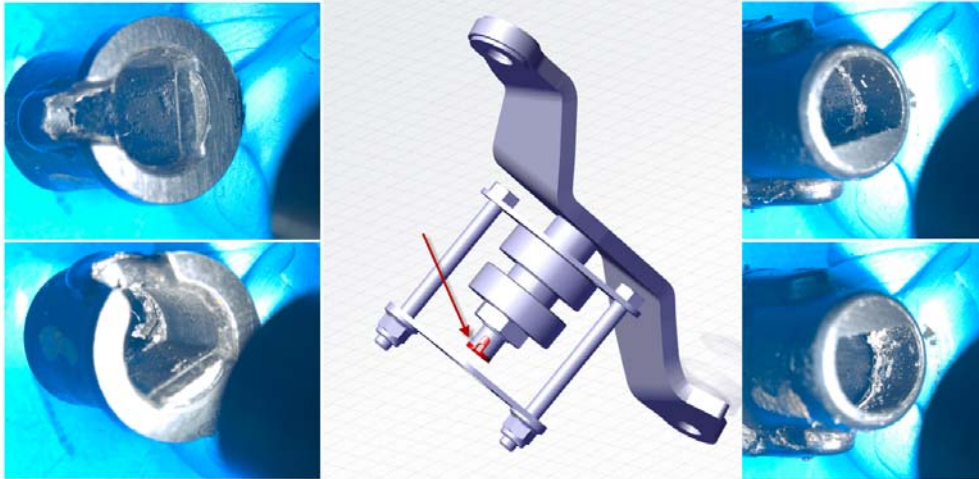
- A good sign that the steering components are too loose is that the SAS plastic bushing will be worn out by the excess of axial movements. The bushing is a tight fit on the SAS shaft. It needs to be replaced if you can easily remove it with your fingers. Here are some examples;
