Advanced Technical Information

Bulletin #: 2234

Improper Odometer and/or Speedometer Function

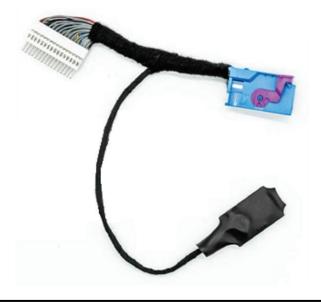
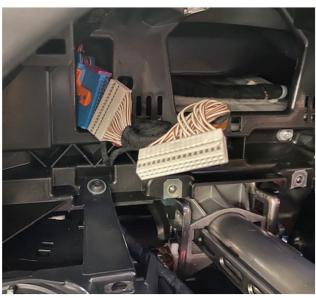
A possible installation of an aftermarket-tampering device between the vehicle wiring harness and the instrument cluster that filters or blocks the signals for distance and speed could explain the concern.

Note: If installed, the device's location is typically behind the instrument cluster.

If an aftermarket device has been found installed in a vehicle, notify the customer and report it to the warranty department via PRMS* with photo documentation.
