992- Turbo and Turbo S PDK II Operation in Manual Mode

Vehicles Affected

Models	Model Year	Model Type	VIN Range	Vehicle-Specific Equipment
911	2020 - 2022	992430 992450 992630 992650	n/a	n/a

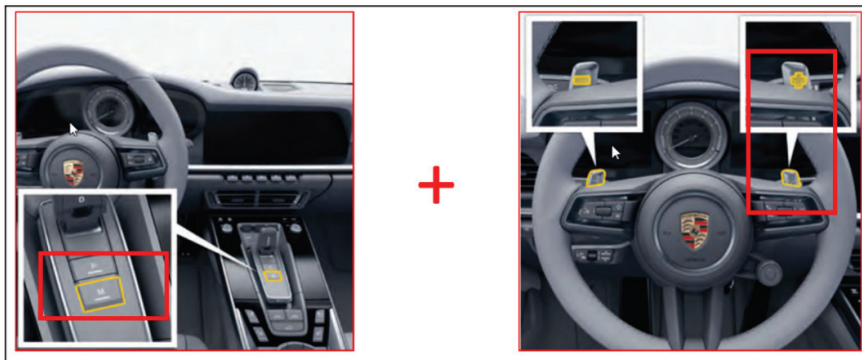
Customer complains an upshift request via the right shift paddle in manual ('M') mode operation from 1st to 2nd gear does not execute in the gearbox. This upshift request fails to execute even at higher engine speeds while operating in 'M.'

Upshift from 1st

2nd Gear is restricted in Manual Mode.

A software strategy in the aforementioned models prohibits the first to second gear upshift in 'M' operation.

A software update to allow the upshift from first to second gear in 'M' for a subsection of the affected vehicles is available for model year 2022 cars in the latest PIWIS tester version. Please update the PDK control unit to software version 0580 in the tester according to standard workshop procedures. This bulletin will be updated accordingly when the software is available for older models.
