173/21 ENU 1950

# Warning Message "Coolant Temperature Too High": Checking Coolant Pump and Change-Over Valve (173/21)

Model Line:Macan S (95B) / Macan GTS (95B) / Macan Turbo (95B)Cayenne (9YA / 9YB)Model Year:As of 2018

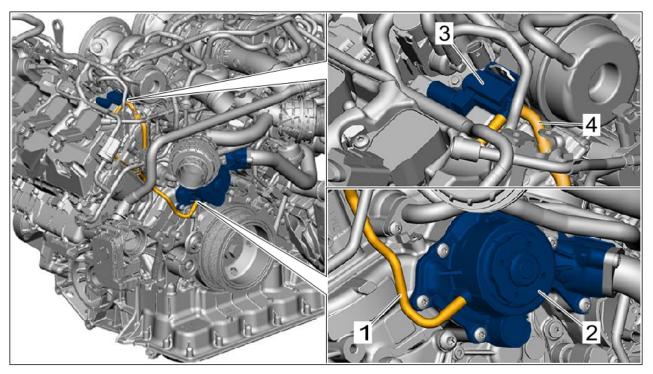
- Concerns: Change-over valve for coolant pump
- Information: The customer complains about a warning message **'Coolant temperature too high'**. A faulty coolant pump is detected as the cause. Internal tests have shown that in some cases, the cause of a faulty coolant pump is due to a faulty change-over valve in the coolant pump.
- Action required: If the coolant pump is faulty or leaking, also check the change-over valve for the coolant pump and replace it if necessary.

- 1 Pull vacuum hose  $\Rightarrow$  Position of change-over valve and coolant pump -1- off the coolant pump  $\Rightarrow$  Position of change-over valve and coolant pump -2-.
- 2 Pull off vacuum hose  $\Rightarrow$  Position of change-over valve and coolant pump -4- from the control valve  $\Rightarrow$  Position of change-over valve and coolant pump -3-.
- 3 VAS 6213 Hand vacuum pump must be ⇒ *Position of change-over valve and coolant pump*-3connected to the change-over valve ⇒ *Position of change-over valve and coolant pump*-4- on the vacuum hose connection. Then build up vacuum.

Stop the test procedure if a vacuum cannot be built up. In this case, the change-over valve is faulty and must be replaced. Continue with Step 5. If a vacuum can be built up, continue with Step 4.

- 4.2 Select the **Drive links/checks** menu.
- 4.3 Select **Drive links** and press F12<sup>"</sup> Next to confirm.
- 4.4 Select 'Activation of vacuum switchover valve for main coolant pump' and press•F8" to start.
  - If the vacuum in the vacuum pump display changes, the change-over valve ⇒ *Position* of change-over valve and coolant pump -3- is intact. Continue with Step 4. In this case, only ⇒ *Position of change-over valve and coolant pump* -2- replace the coolant pump if it is faulty.
  - If the vacuum in the vacuum pump display does not change, the change-over valve ⇒ Position of change-over valve and coolant pump -3- and the coolant pump ⇒ Position of change-over valve and coolant pump -2- must be replaced, if necessary, if the coolant pump is ⇒ Position of change-over valve and coolant pump -2- also faulty.

- 5 VAS 6213 Hand vacuum pump must now be disconnected from the vacuum hose ⇒ *Position of change-over valve and coolant pump* -1-.
- 6 Install vacuum hose  $\Rightarrow$  *Position of change-over valve and coolant pump*-1- on coolant pump  $\Rightarrow$  *Position of change-over valve and coolant pump*-2-.
