Traces of Coolant Close to the Coolant Reservoir or Under the Vehicle (241/22)

Model Line: **718 Boxster (982) / 718 Cayman (982)
911 (992)**

Model Year: **As of 2022**

Concerns: **Coolant reservoir cap**

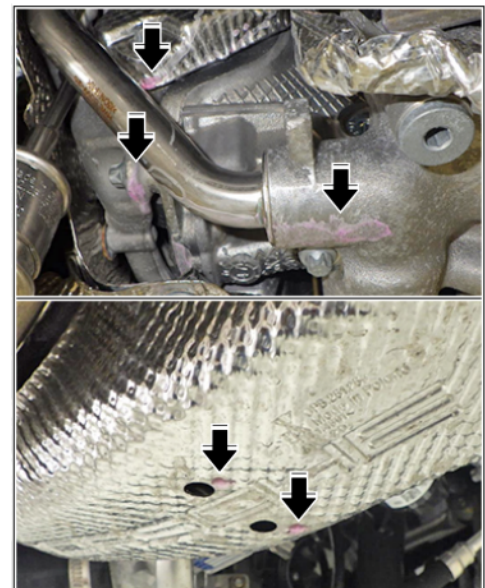
Coolant leaking in this area ⇒ *Traces of coolant -Arrows-* is often due to a correct release of excess pressure through the cap.

This can occur, for example, due to heat or strong movement of the vehicle during loading and transportation on a ship. For this reason, some of the incidents are already noticed during the handover inspection as part of the sales check.

Traces of coolant

Action required: If traces and residues of coolant can be seen, then the cooling system must be checked before replacing the cap or other components. For work procedure, see: ⇒ *Workshop Manual '190101 Checking cooling system'*

If the leak test shows no leakage from the cooling system, remove any coolant residue with a clean cloth. These traces and residues of coolant do not constitute a defect with regard to the tightness of the cooling system and do not entitle the user to replace the sealing cap.
