TECHNICAL SERVICE BULLETIN

Classification: AN21-019B	Reference: NTB21-085B	Date: December 19, 2022
------------------------------	--------------------------	----------------------------

SOFTWARE UPDATE FOR INFOTAINMENT ISSUES

APPLIED VEHICLES: 2021-2022 Rogue (T33)
APPLIED GRADES: S grade only

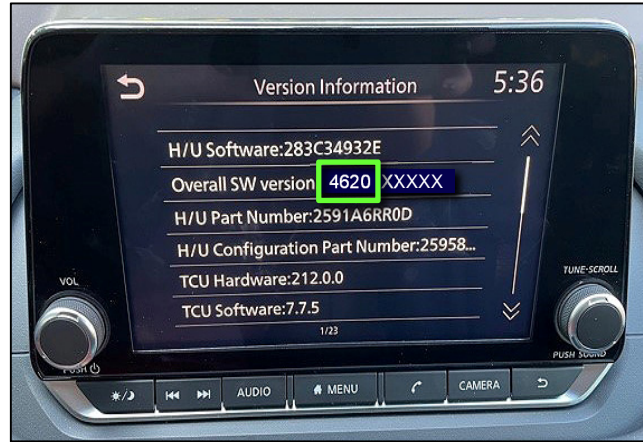
Figure 5

4. Confirm if the **Overall SW version** begins with “4620”.

- If the **Overall SW version** does not begin with “4620”, select the back icon and continue to step 5 on the next page.
- If the **Overall SW version** begins with “4620”, this bulletin does not apply. Select the back icon, and refer to **CLAIMS INFORMATION** on the last page.

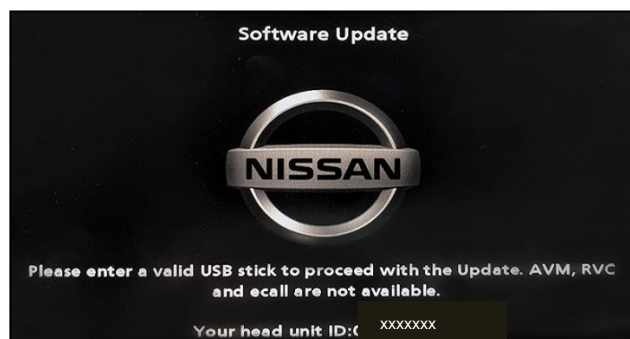
- The screen in Figure 14 may briefly appear. **Do not remove the USB drive.** The audio system will detect the USB and continue the update.
