TECHNICAL SERVICE BULLETIN

Classification: AN22-019B	Reference: NTB22-058B	Date: December 19, 2022
------------------------------	--------------------------	----------------------------

SOFTWARE UPDATE FOR INFOTAINMENT ISSUES

APPLIED VEHICLES: 2020-2023 LEAF (ZE1)
APPLIED GRADES: 2020-2021 LEAF – All
2022 LEAF – SV and SL
2023 LEAF – SV

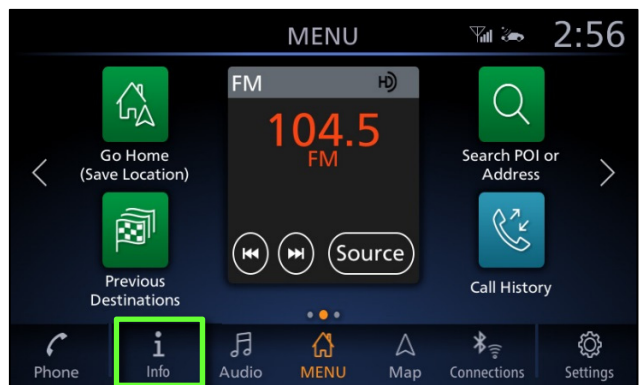
Figure 3

- If the **Info** icon does not appear, as shown in Figure 3, this bulletin does not apply.

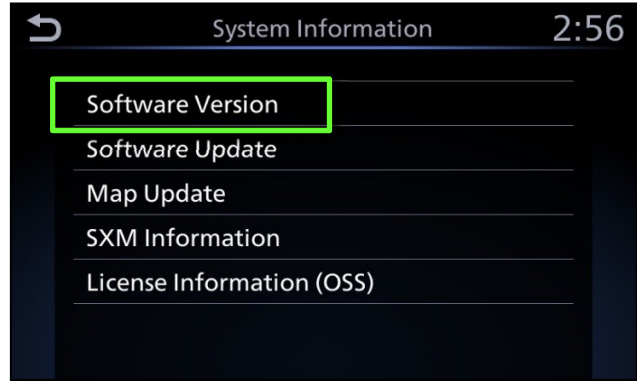
Figure 5

- If the **Software Version** is "344", "345" or "347", select the back icon and continue to step 5 on page 5.
- If the **Software Version** is "354", the infotainment system already has the latest version. Select the back icon, and then proceed to **CLAIMS INFORMATION**.

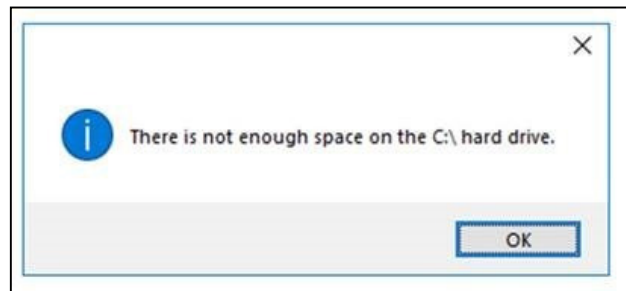
Figure 9

- The update-software is estimated to take **4 hours** to download to the USB drive.
- If, while attempting to download the software to the CONSULT PC, you receive the message shown in Figure 9:
 - Attempt to clear space on the CONSULT PC hard drive.

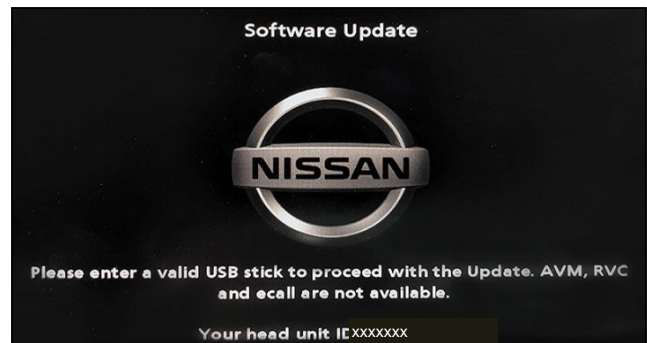
- The screen in Figure 15 may briefly appear. **Do not remove the USB drive.** The audio system will detect the USB and continue the update.
