TECHNICAL SERVICE BULLETIN

Classification: BT22-023	Reference: NTB22-104	Date: December 12, 2022
-----------------------------	-------------------------	----------------------------

DIAGNOSING DOOR LOCK OPERATION

APPLIED VEHICLES: 2021-2023 Altima (L34)
2022-2023 Frontier (D41)
2022-2023 Pathfinder (R53)
2021-2023 Rogue (T33)
2021-2022 Sentra (B18)

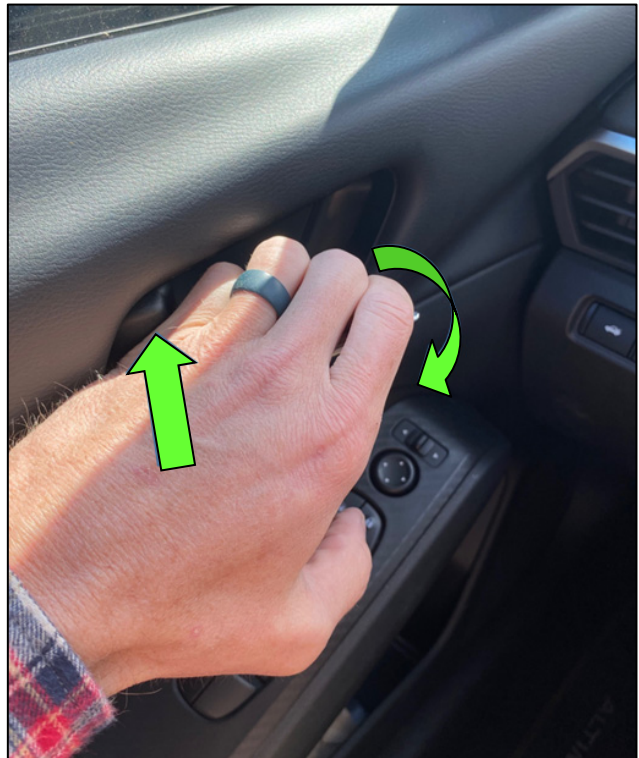
Figure 1

- If the Inside Lock Knob is positioned somewhere between fully locked and fully unlocked, it can result in the door becoming stuck in the half-lock position, and cause the power lock to be unresponsive.

- This can be caused by contact with the Inside Lock Knob as the Inside Handle is actuated to open the door from inside the vehicle and is not a defect. Do not replace the Door Lock as it can happen just as easily with the replacement Door Lock.

- Demonstrate to the customer what is believed to be causing their concern.
 - a. Show that it is possible to inadvertently move the Inside Lock Knob with the heel of your hand when pulling the Inside Handle to exit the vehicle.

- b. If the concern happens again, ask the customer to confirm if the Inside Lock Knob is partially or fully locked. The concern should be resolved by manually unlocking the door with the Inside Lock Knob.
 - If this concern is confirmed, a slightly altered approach to opening the door can be used to avoid inadvertent contact with the Inside Lock Knob.
- c. If the issue persists and it is confirmed that the Inside Lock Knob was not moved, proceed to step 4.
