STAR ONLINE PUBLICATION

Case Number: S2008000131 Rev. D

Symptom/Vehicle Issue: U11E9 Lost Communication with AGS (Active Grille Shutter), Malfunction Indicator Lamp (MIL) Illuminated

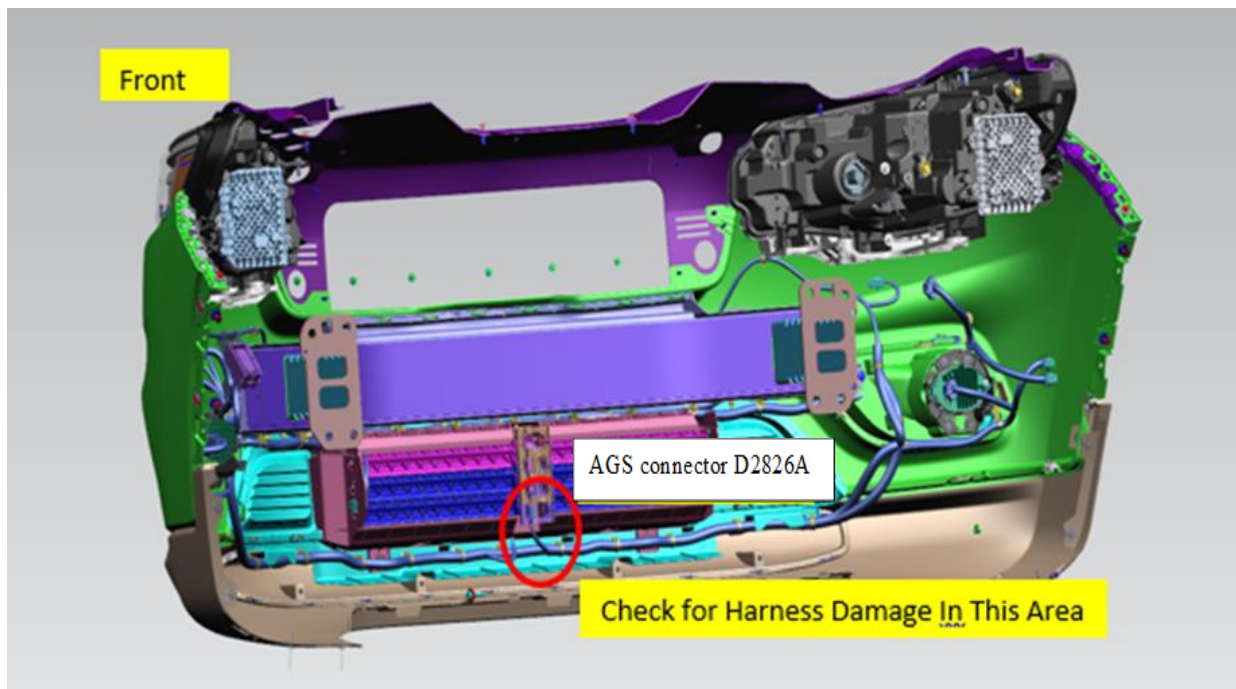
Repair Procedure: Inspect the below suspect connector and wiring harness locations for signs of damage. Inspect harness as needed at suspect locations looking for stretched or twisted circuit wires (example below). Disconnect and reconnect the AGS Connector (D2826A) to ensure it is properly seated if no signs of damage or corrosion.

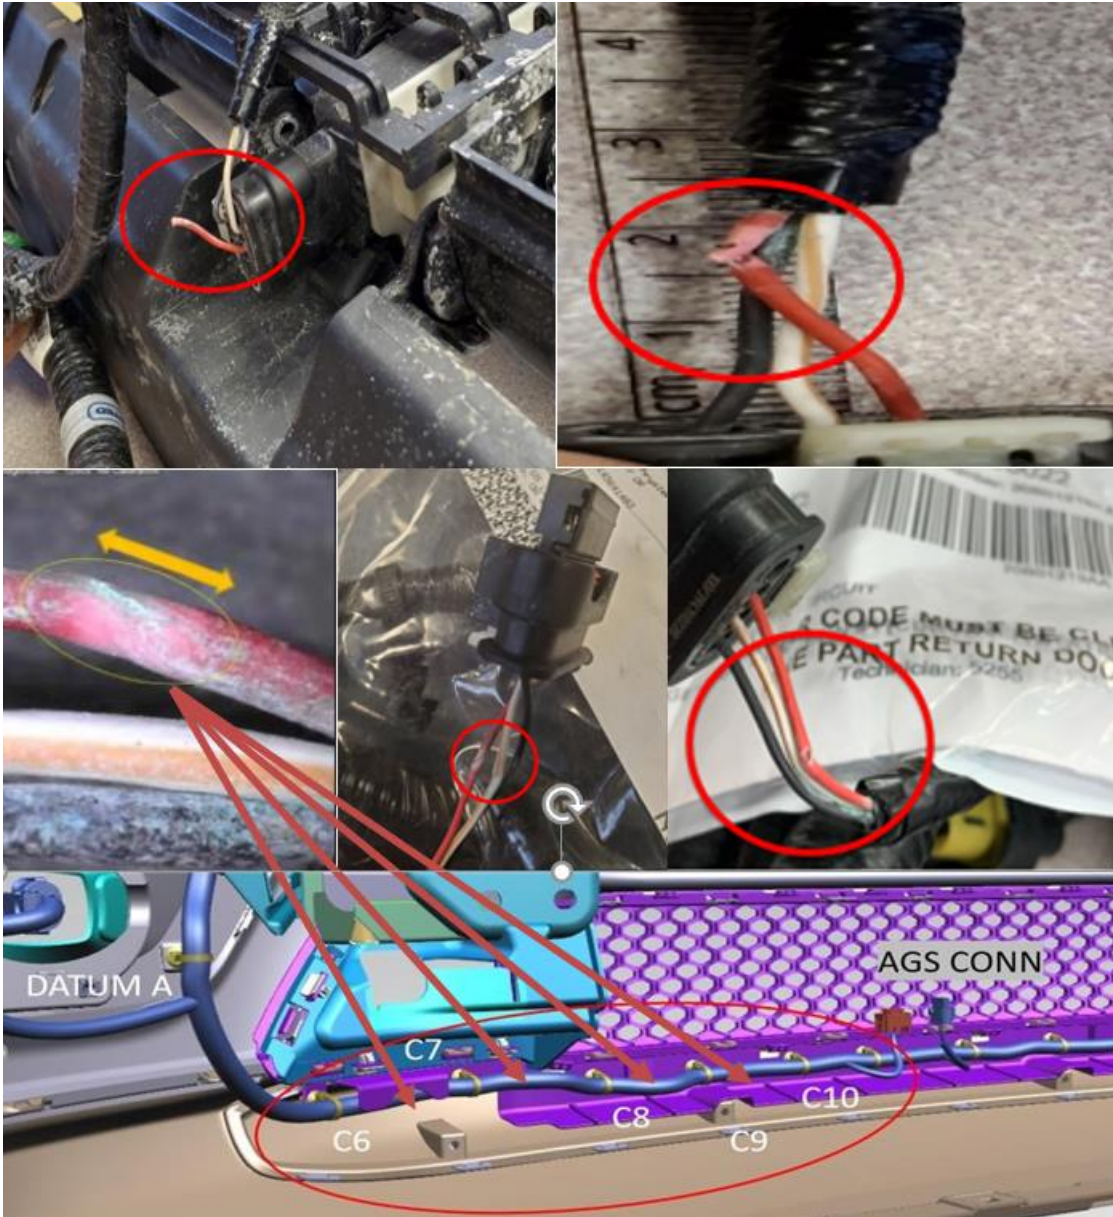
Damaged AGS Wiring and Connector Location Points

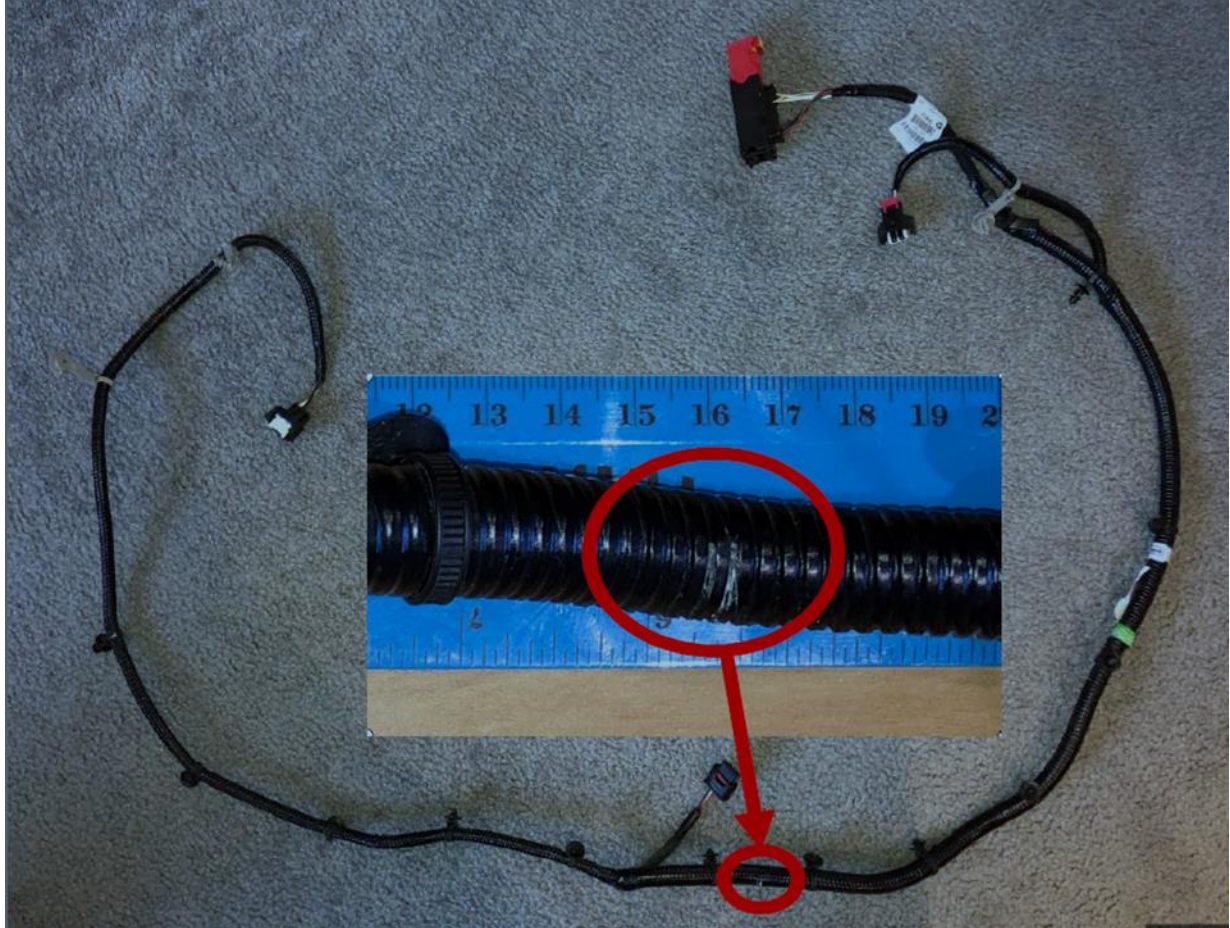
Damaged AGS Wiring Harness Example Location

A 4-way AGS connector repair kit 68396618AB is available for damaged or corroded connector conditions that cannot be repaired. Repair any suspect harness areas identified using the standard harness repair process in Service Library before replacing the harness.
