STAR ONLINE PUBLICATION

Case Number: S2208000194

Symptom/Vehicle Issue: Right or Left Reverse Back Up Lamp Inoperative, Cluster Warning Message for a Lamp Out

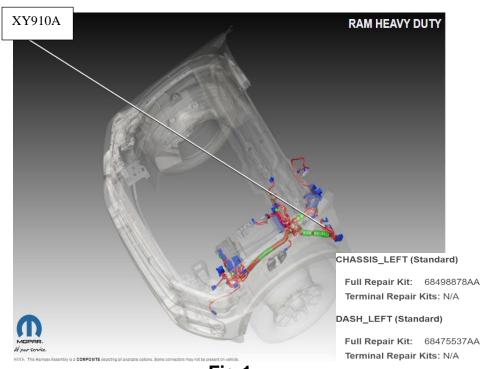
Customer Complaint/Technician Observation: Owner complains of a lamp out message displayed on the cluster with a reverse lamp out. Technician observed the vehicle sets either Diagnostic Trouble Code (DTC) B1707-15 Left or B170B-11 Right, Reverse Lamp Control Circuit.

Repair Procedure: Inspect connector XY910A 48-way grey and black connector at the rear of the left front wheel well. Examine the connector for any bent and/or pushed out terminals. Inspect the harness routing at the left front body mount for signs of contact or chaffing. Repair or replace any bent or pushed out terminals and isolate and reposition the harness as needed Fig 1 and 2.

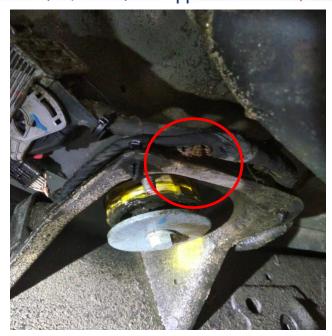
Fig 2

Picture above shows BAD/DEFECTIVE part. The issue
