## STAR ONLINE PUBLICATION

**Case Number:** S2208000147

**Symptom/Vehicle Issue:** Vehicle Does Not Respond. wiTech Has Limited Or No Communication With The Vehicle. U0001-00 For CAN C Bus

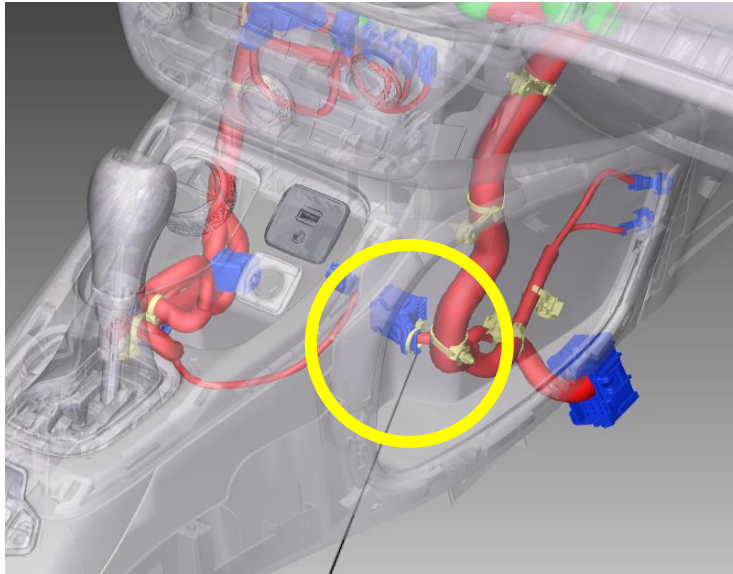
**ORC Connector Under Floor Console**

If a short to ground on CAN C +/- is found. The short may be caused by a bolt pinching/crushing the wiring harness under the floor console near the ORC. Remove the floor console and inspect the wiring harness.

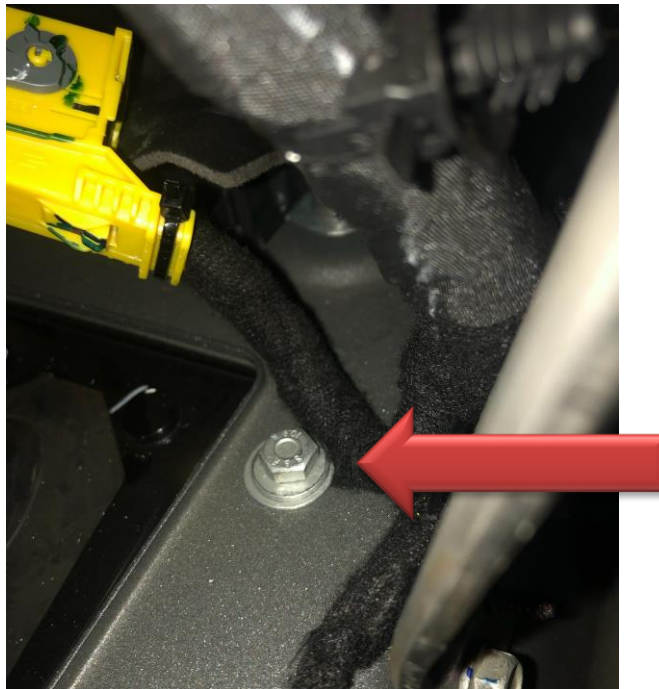
**Wiring Harness Crushed Under Bolt**

**Repair Procedure:** Repair any damaged circuits using standard wiring repair practices. If necessary, replace the wiring harness.

**Verification:** Confirm that the short to ground no longer exists, communication with wiTech is established and vehicle operation is restored.
