Case Number: S2208000197

Release Date: December 2022

Symptom/Vehicle Issue: Cluster Message "Service Air Suspension"

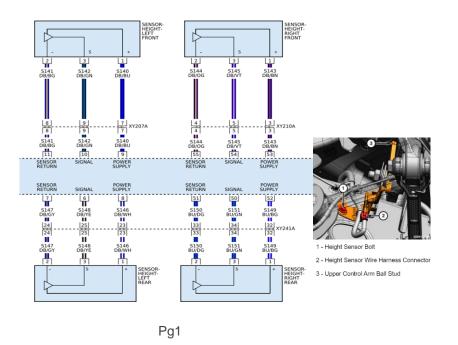
**Customer Complaint/Technician Observation:** Owner complains of a cluster message to service the air suspension of the vehicle. Technician observed Diagnostic Trouble Codes (DTCs) C152A-15 Right Rear Ride Height Sensor Short to Battery or Open and/or C1526-15 Left Rear Ride Height Sensor Short to Battery or Open.

**Repair Procedure:** If DTCs C152A-15 & C1526-15 open circuit / short to battery were stored or active. Disconnect the height sensor and inspect the connector and terminals for loose or pushed out terminals. Inspect for any contaminates within the connector and clean and re-connect the sensor. Ensure the connector is fully seated and the connector retaining lock is secure. Use the scan tool to perform the height sensor operational check prior to any component replacement. The test will validate the system and component functionality, pg 1 and 2.
