STAR ONLINE PUBLICATION

Case Number: S2219000007

Symptom/Vehicle Issue: Service Electric Power Steering (EPS) Message Displayed on Cluster Upon Start Up

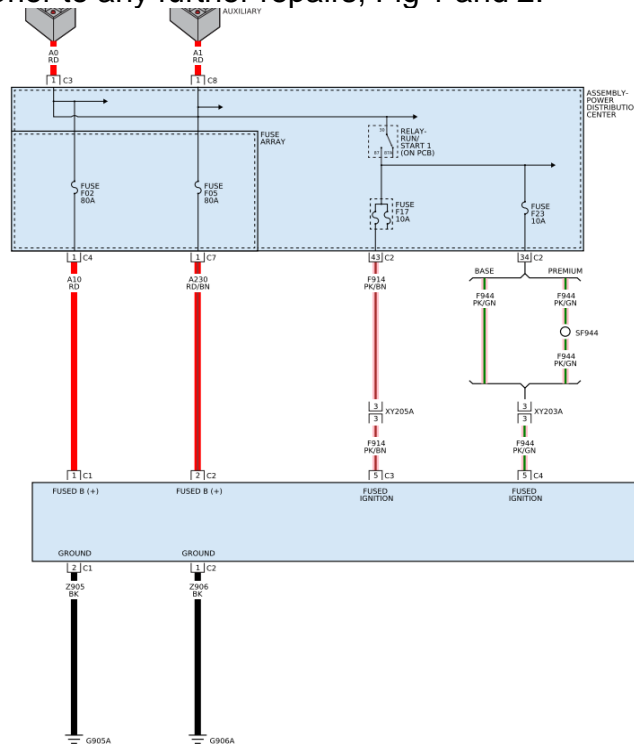
Customer Complaint/Technician Observation: Owner complains of a cluster message to service the EPS system shortly after starting the vehicle. Technician observed the Diagnostic Trouble Codes (DTCs) C2217-00 EPS Module Internal, and C1592-00 EPS Motor Circuit were set at the same time, within the same ignition cycle.

Discussion: When the above DTCs are setting as described above, it is best to check the battery charge level (charge as needed) and then check the EPS redundant B+ feeds and grounds (G905a G906A) for any voltage drop prior to any further repairs, Fig 1 and 2.
