WARRANTY BULLETIN

NO: D-22-17

SUBJECT: 2017 – 2023 (Current) Chrysler
Pacifica (RU) and 2013 – 2016 Chrysler
Town & Country/ 2013 – 2020 Dodge
Caravan (RT) - Corrosion – **Complete
Hood Panel Warranty Claim**

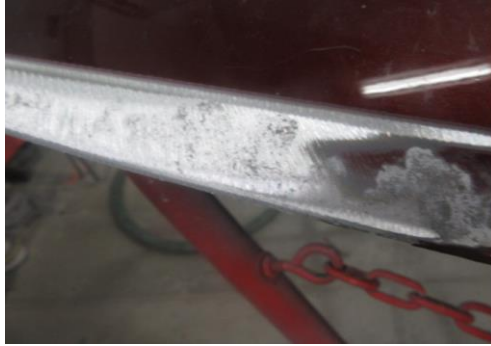
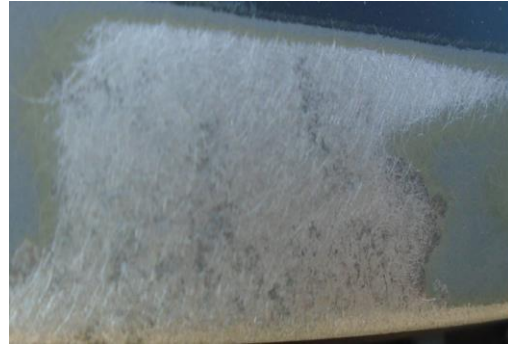
1. Perforation/ Pitting found during the sanding process (Fig. 1)

Perforation/Pitting Found After Sanding Examples (Fig. 1)

Note: If pitting is found during the sanding process, please use LOP 23-75-21-01 for up to 0.5 hours in conjunction with the 23-85 replacement LOP.

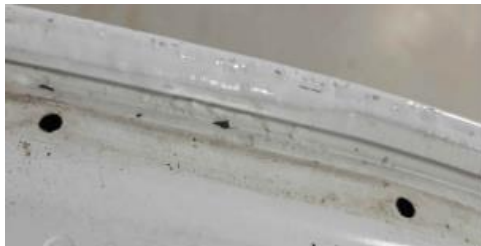
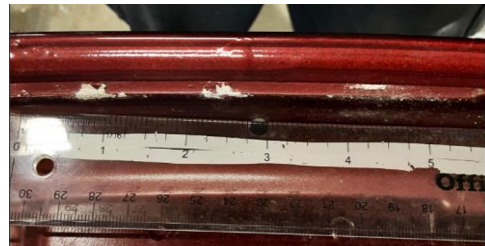
2. Corrosion found on the Hem Flange on the underside of the hood (Fig. 2)

Hem Flange Area Examples (Fig. 2)

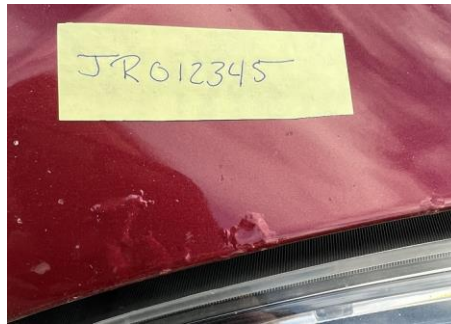
VIN Example (Fig. 3)

Photos to support corrosion repairs or replacement must show the VIN in the photo. The VIN can be written on masking tape, on the panel with a grease pen or a sticky note. The important part is that the VIN **MUST** be seen near the corrosion area to support the repair as seen in (Fig 3).
