NUMBER: 23-052-22

Water Leak in Rear Cargo Area

2023 (WL) Grand Cherokee

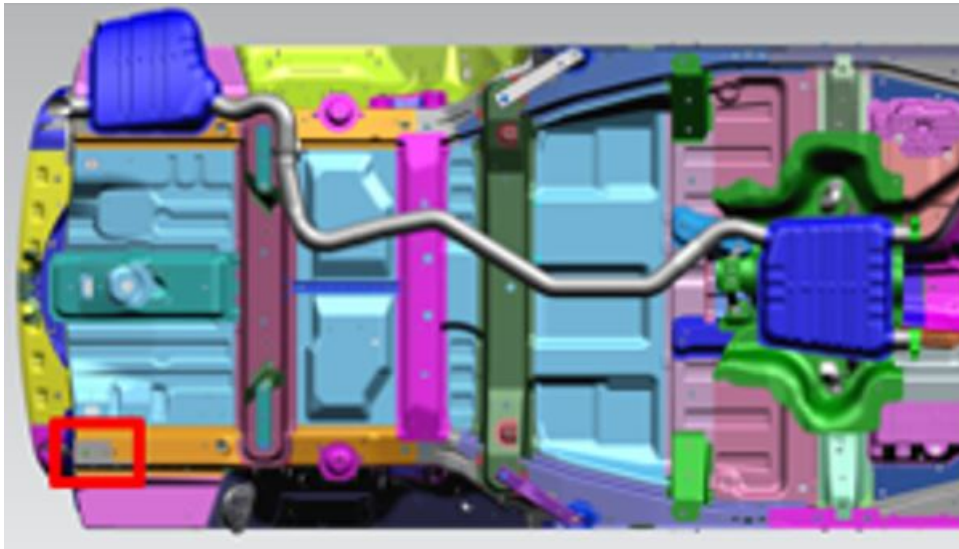
Fig. 1
Bolt Hole Location

2. Locate two open bolt holes located at the left rear of the vehicles (Fig. 1) and (Fig. 2) .

3. Clean the area with alcohol.
4. Apply foil tape over the open bolt holes.
5. Lower the vehicle. This bulletin has been completed.

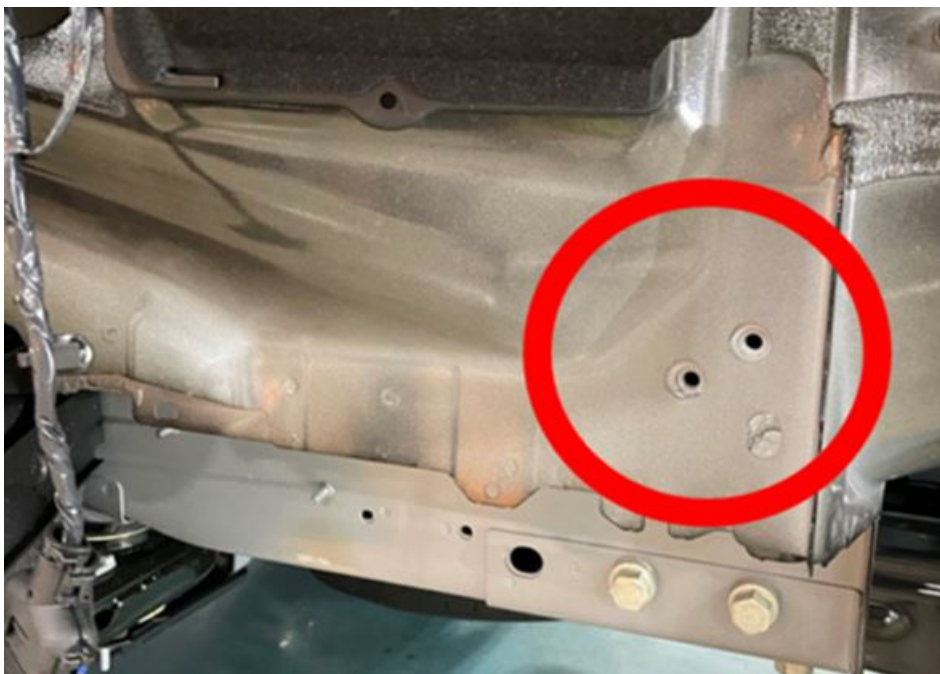
Fig. 2
Open Bolt Holes

NOTE: If the vehicle was equipped with a dual exhaust these two bolt holes would be used for the bolts of the rear exhaust hanger.
