Technical Service Bulletin (TSB)
UAQ and UCQ Radio Enhancements

REFERENCE:	TSB: 08-003-22 REV. A GROUP 08 - Electrical	Date:	December 16, 2022	REVISION:	08-003-22 and 08-133-21
VEHICLES AFFECTED:	<p>2019 - 2023 (KL) Jeep Cherokee 2018 - 2020 (WD) Dodge Durango 2018 - 2021 (MP) Jeep Compass 2019 - 2021 (BV) Jeep Renegade 2018 - 2022 (LA) Dodge Challenger 2018 - 2022 (LD) Dodge Charger 2018 - 2022 (LX) Chrysler 300 2018 - 2023 (JL) Jeep Wrangler 2020 - 2023 (JT) Jeep Gladiator 2018 - 2021 (DS) RAM 1500 Pickup 2018 (WK) Jeep Grand Cherokee 2018 (BU) Jeep Renegade 2018 (DJ) RAM 2500 Pickup 2018 (D2) RAM 3500 Pickup 2018 (DD) RAM 3500 Cab Chassis 2018 (DF) RAM 3500 <10K Cab Chassis 2018 (DP) RAM 4500/5500 Cab Chassis</p> <p>NOTE:This bulletin applies to vehicles equipped with a Uconnect 4C Nav With 8.4" Display radio (Sales Codes UAQ or UCQ).</p> <ul style="list-style-type: none"> This bulletin applies to JL and JT vehicles built on or before November 23, 2022 (MDH 1123XX). This bulletin applies to KL vehicles built on or before November 21, 2022 (MDH 1121XX). 				<p>MARKET APPLICABILITY:</p> <p><input checked="" type="checkbox"/> NA <input type="checkbox"/> IAP <input type="checkbox"/

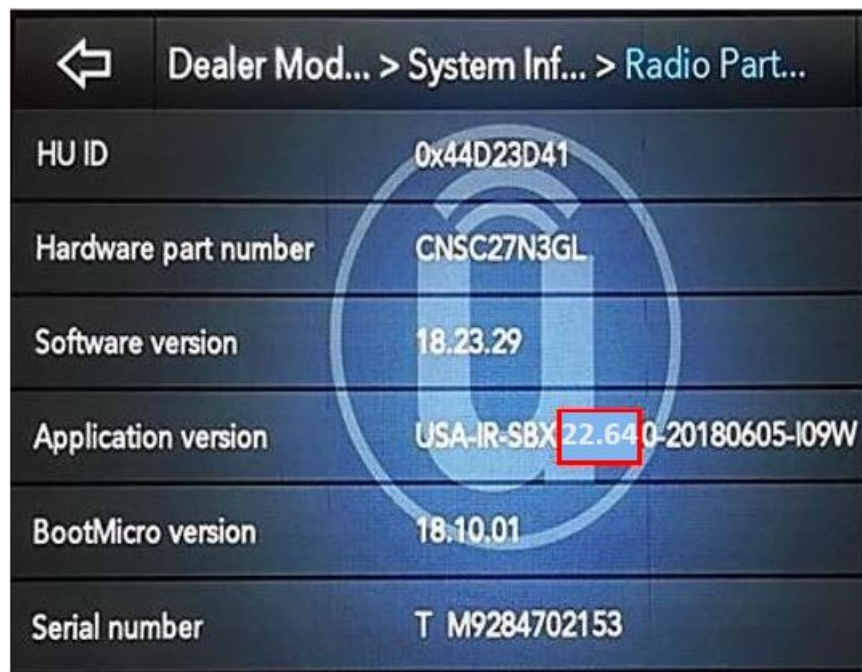
Fig. 1
Radio Software Level Screen

1. Verify the radio software version. Radio must be in Dealer Mode to verify by following these steps:
 - a. Press and hold both lower corners of the display screen, until the Dealer Mode screen appears (approximately seven seconds). Release screen.
 - b. Select "Radio Part Information". The software version will be listed next to "Application Version" (Fig. 1).

2. What is the current radio software level (Application Version)?
 - 40.1 or higher >>> The radio software is already up to date. Normal diagnostics should be performed.
 - At or above 22.64 and under 40.1 >>> The radio will only need one USB update. Proceed to [Step 1](#) of the Repair Procedure.
