| REFERENCE: | TSB: 08-234-22 GROUP 08 - Electrical | Date: | December 16, 2022 | REVISION: | 08-138-21 and 08-105-21 REV. A |

| CAUSE: | Radio software |

REPAIR SUMMARY:

This bulletin involves inspecting and if required, updating the radio software level to 40.1. Depending on the radio's current software level the radio may need a one or two USB update.

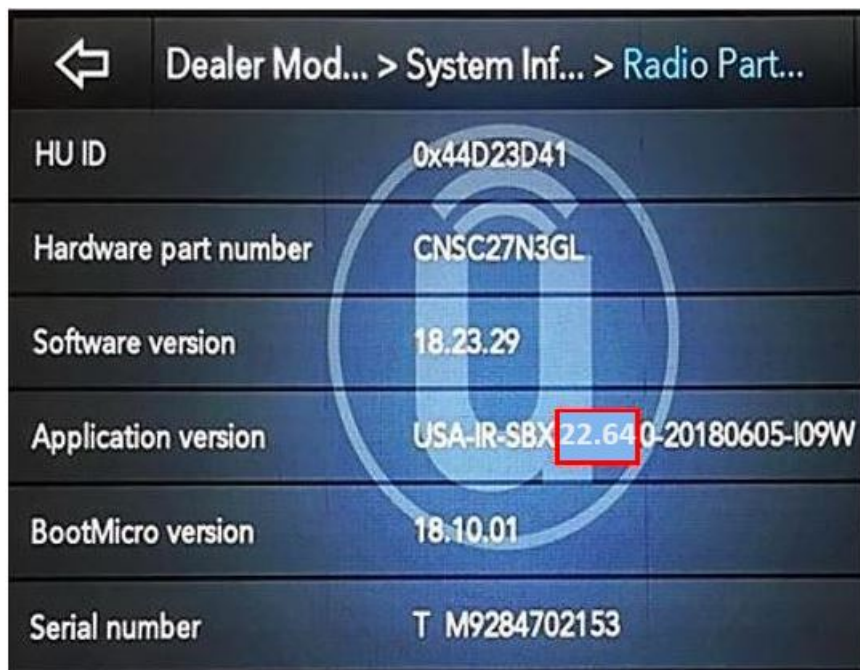
Fig. 1
Radio Software Level Screen

1. Verify the radio software version. Radio must be in Dealer Mode to verify by following these steps:
 - a. Press and hold both lower corners of the display screen, until the Dealer Mode screen appears (approximately seven seconds). Release screen.
 - b. Select "Radio Part Information". The software version will be listed next to "Application Version" (Fig. 1).

2. What is the radio software level (Application Version) at?
 - 40.1 or higher >>> The radio software is already up to date. Normal diagnostics should be performed.
 - At or above 22.64 and under 40.1 >>> The radio will only need one USB update. Proceed to [Step 1](#) of the Repair Procedure.

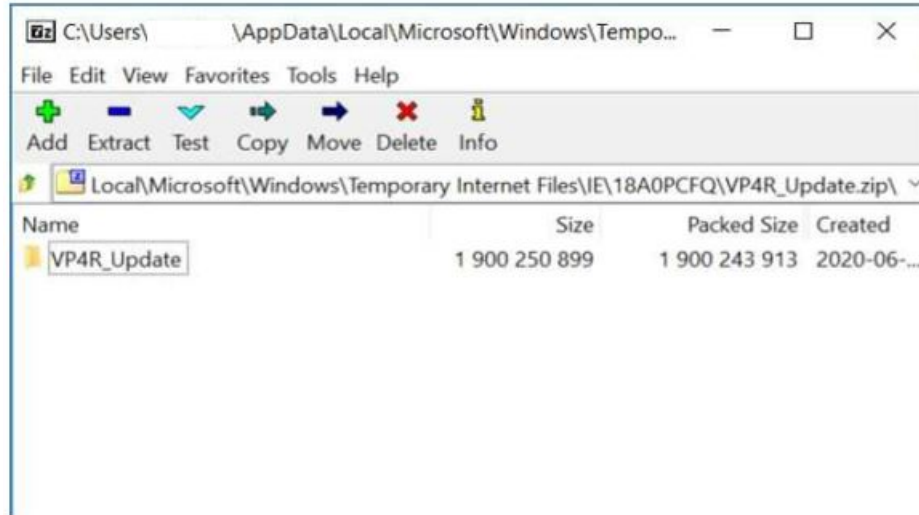
Fig. 3

Files/Folders In The USB Flash Drive

7. Unzip the file to the root folder of USB flash drive. File should not be within a zip folder. Your USB file should look like (Fig. 3) when you open it.

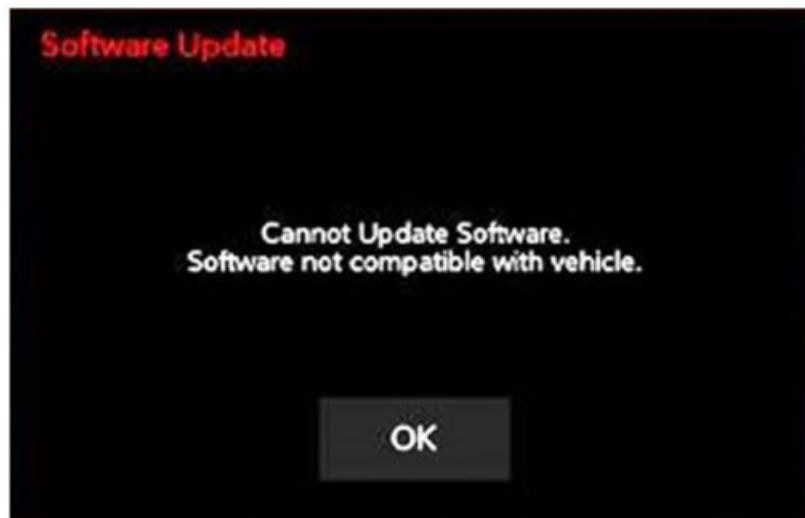
Fig. 4

10. If the screen in (Fig. 4) is displayed, the USB flash drive was not set up correctly. Use a top name brand USB flash drive, like Kingston, create a new USB flash drive and start the update again.

Software Not Compatible Screen

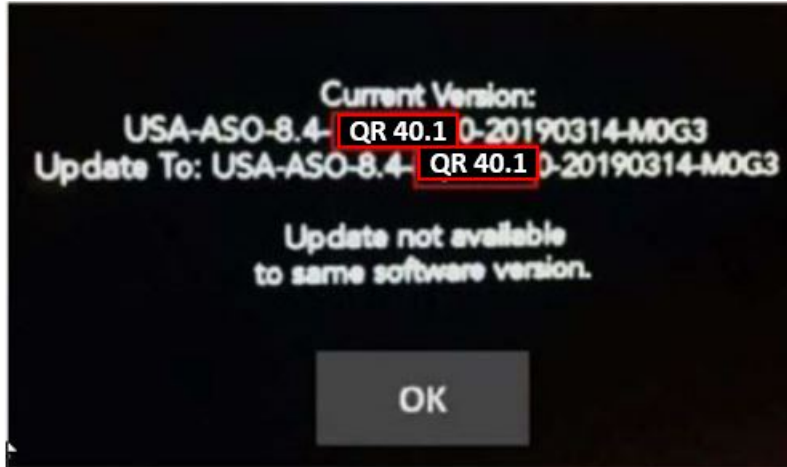
Fig. 5
Screen Displayed When Radio Software Level Is Up To Date

11. If the radio software is already up to date, the screen in (Fig. 5) will be displayed. Press “OK” and remove the USB flash drive.

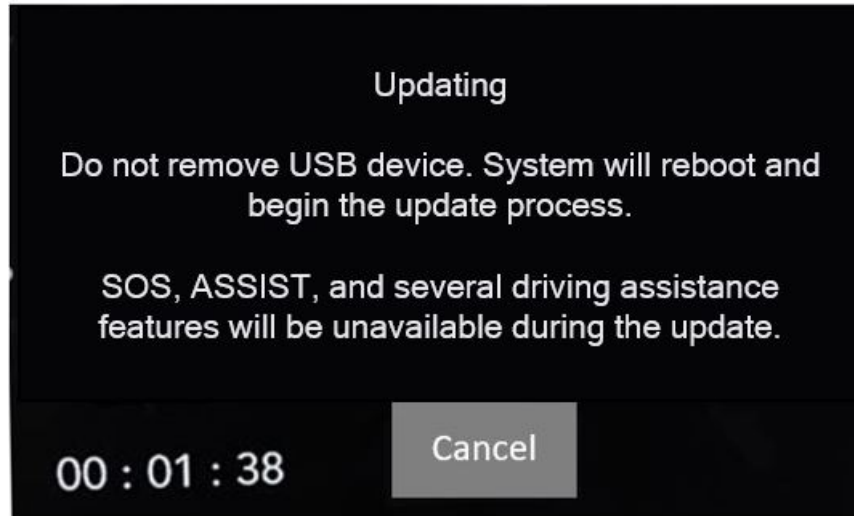
Fig. 7
Updating Screen

13. When the radio starts updating, the screen in (Fig. 7) will be displayed.

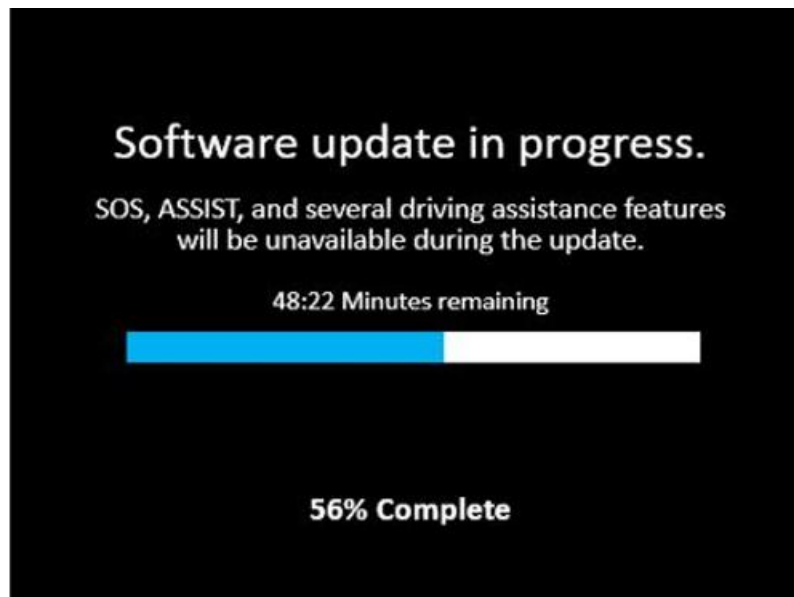
Fig. 8
Software Update In Progress

14. The radio will reboot and the update will begin. The update should only take 25 minutes, the timer on the screen may display the incorrect time remaining, (Fig. 8) .

NOTE: The completion indicator may not reach 100%, even though the software update has been completed. Once the software update has finished, the radio and display screen will turn off.

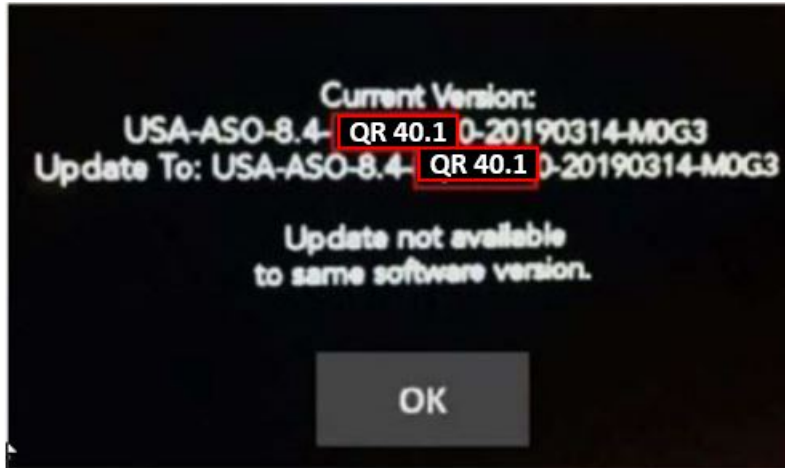
Fig. 9
Radio Software Has Been Updated

15. After the update has completed, the radio will shut down. With the USB flash drive still inserted in the USB port, cycle the ignition back (if it was turn off) to the run position. If the radio software was updated correctly the “Current Version:” and the “Update To:” software levels in (Fig. 9) will display the identical software level. Press “OK” and remove the USB flash drive.
