REFERENCE:	TSB: 08-235-22 GROUP 08 - Electrical	Date:	December 21, 2022	REVISION:	08-083-18 REV. B
VEHICLES AFFECTED:	<p>2017 - 2018 (MP) Jeep Compass</p> <p>NOTE:This bulletin applies to vehicles built on or before January 12, 2018 (MDH 0112XX) equipped with a Uconnect 4C Nav With 8.4” Display radio (Sales Codes UDQ or UGQ).</p> <p>NOTE:This bulletin applies to vehicles built on or before January 20, 2018 (MDH 0120XX) equipped with a Uconnect 4C Nav With 8.4” Display radio (Sales Codes UAQ).</p> <p>NOTE:This bulletin applies to vehicles built on or before July 18, 2018 (MDH 0718CC) equipped with a Uconnect 4C Nav With 8.4” Display radio (Sales Codes UCQ).</p>			MARKET APPLICABILITY:	
				<input checked="" type="checkbox"/> NA	<input checked="" type="checkbox"/> MEA
				<input checked="" type="checkbox"/> SA	<input type="checkbox"/> IAP
				<input checked="" type="checkbox"/> EE	<input type="checkbox"/> CH

This bulletin involves inspecting and if required, updating the radio software level to 18.7 (UGQ or UDQ)

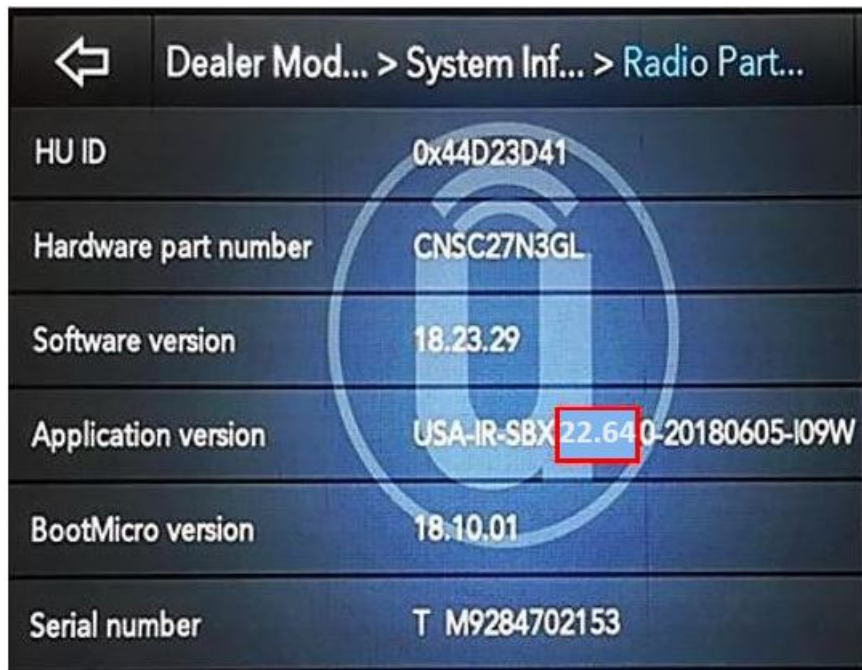
Fig. 1
Radio Software Level Screen

1. Verify the radio software version. Radio must be in Dealer Mode to verify by following these steps:
 - a. Press and hold both lower corners of the display screen, until the Dealer Mode screen appears (approximately seven seconds). Release screen.
 - b. Select "Radio Part Information". The software version will be listed next to "Application Version" (Fig. 1) .

2. Is the radio software level 18.7 (UGQ or UDQ) **18.8 (UAQ or UCQ)** or higher?
 - YES >>> The radio software is already up to date. Normal diagnostics should be performed.
 - NO >>> The radio will need to be updated. Proceed to [Step 3](#) of the Inspection Procedure.
3. Does the vehicle have a UGQ radio?
 - YES>>> Proceed to [Step 4](#) of the Inspection Procedure.
 - NO>>> Proceed to [Step 1](#) of the Repair Procedure

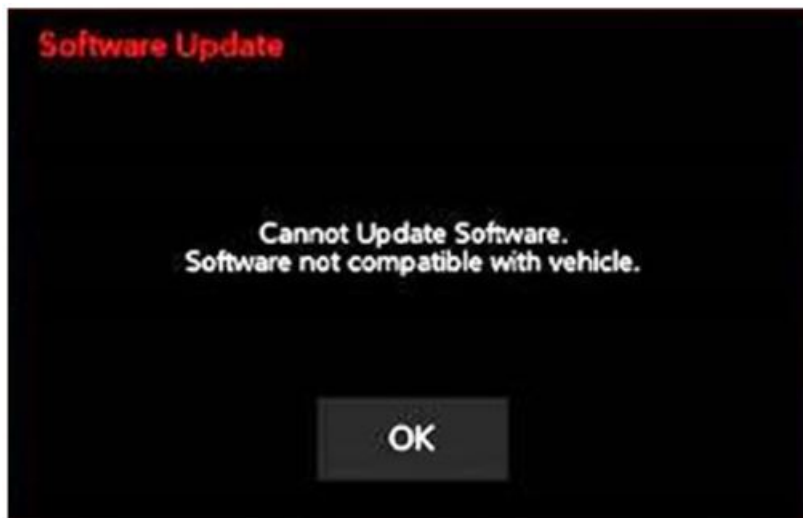
Fig. 4
Software Not Compatible Screen

10. If the screen in (Fig. 4) is displayed, the USB flash drive was not set up correctly. Use a top name brand USB flash drive, like Kingston, create a new USB flash drive and start the update again.

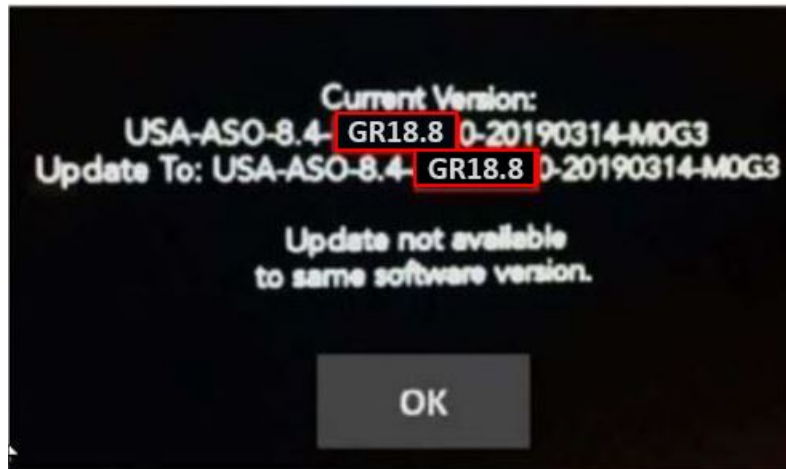
Fig. 5

11. If the radio software is already up to date, the screen in (Fig. 5) will be displayed. Press “OK” and remove the USB flash drive.

Screen Displayed When Radio Software Level Is Up To Date

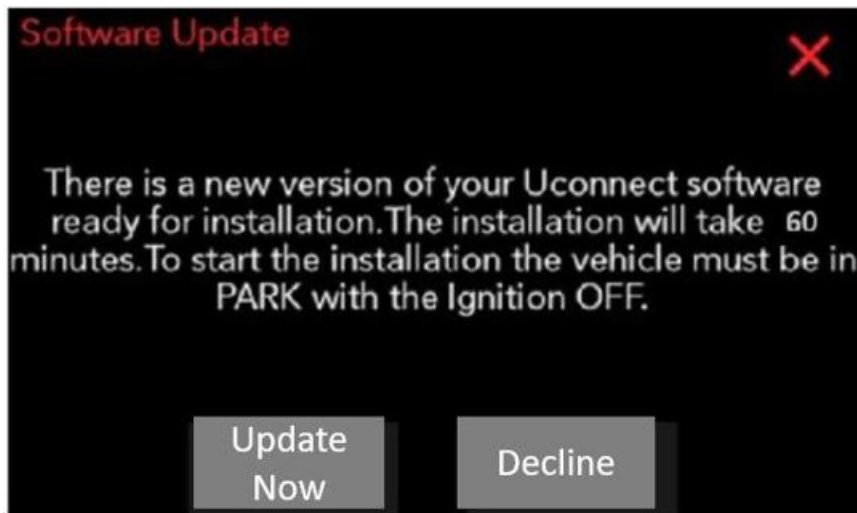
Fig. 6

Software Update Is Available

12. Once the system has verified there is an available update, press the “Update Now” button. Make sure the vehicle is in park, **DO NOT** turn off the ignition (Fig. 6) .

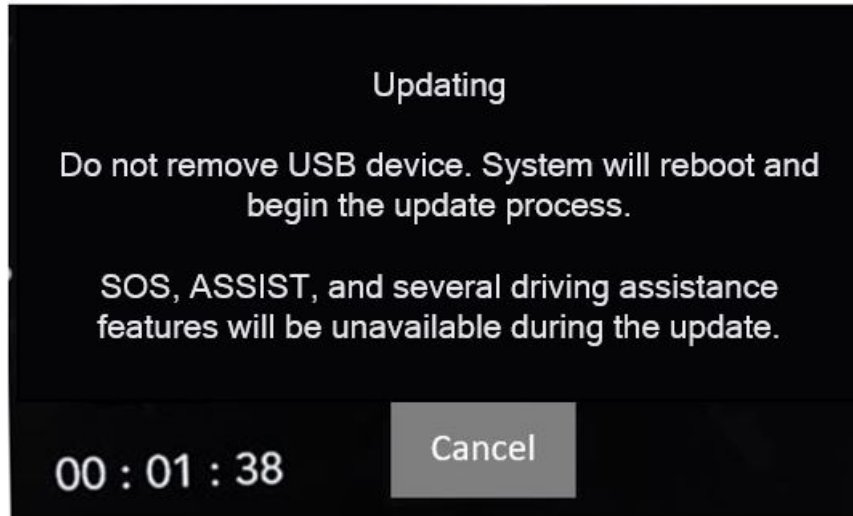
Fig. 7
Updating Screen

13. When the radio starts updating, the screen in (Fig. 7) will be displayed.

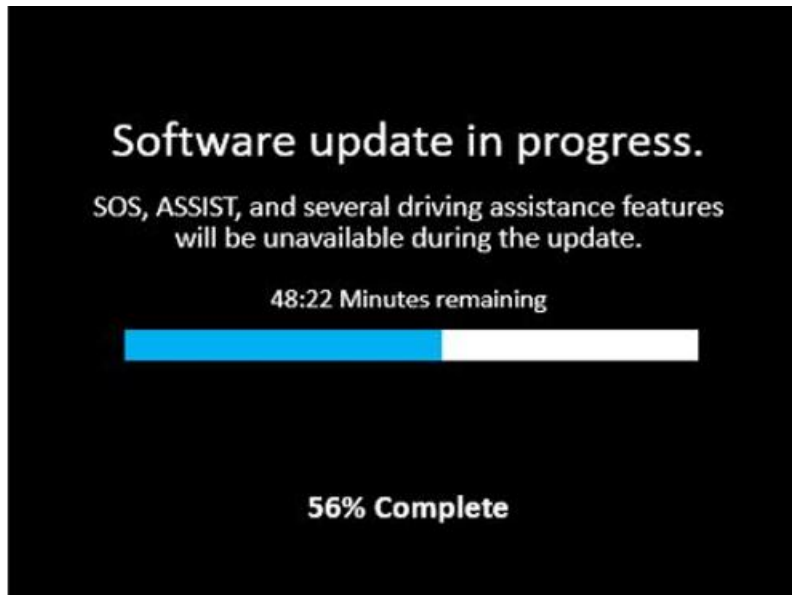
Fig. 8
Software Update In Progress

14. The radio will reboot and the update will begin. The update should only take 25 minutes, the timer on the screen may display the incorrect time remaining, (Fig. 8) .

NOTE: The completion indicator may not reach 100%, even though the software update has been completed. Once the software update has finished, the radio and display screen will turn off.

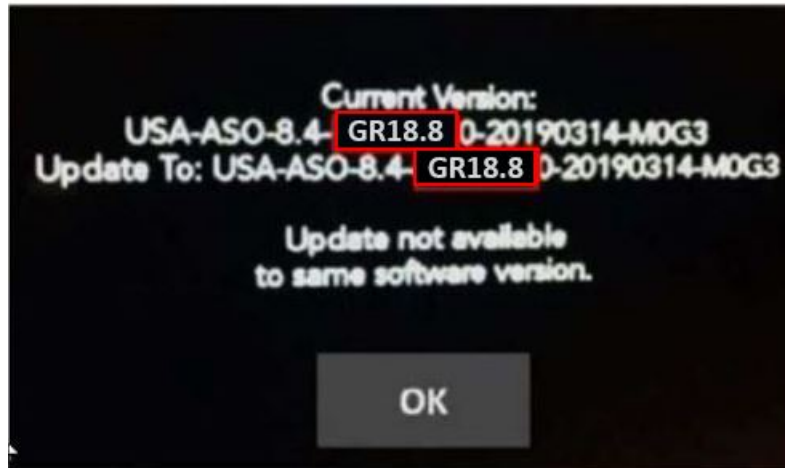
Fig. 9

15. After the update has completed, the radio will shut down. With the USB flash drive still inserted in the USB port, cycle the ignition back (if it was turn off) to the run position. If the radio software was updated correctly the “Current Version:” and the “Update To:” software levels in (Fig. 9) will display the identical software level. Press “OK” and remove the USB flash drive.

Radio Software Has Been Updated
