NUMBER: 09-015-22

Engine Vibration Noise When Idling in Gear

Jeep Grand Cherokee

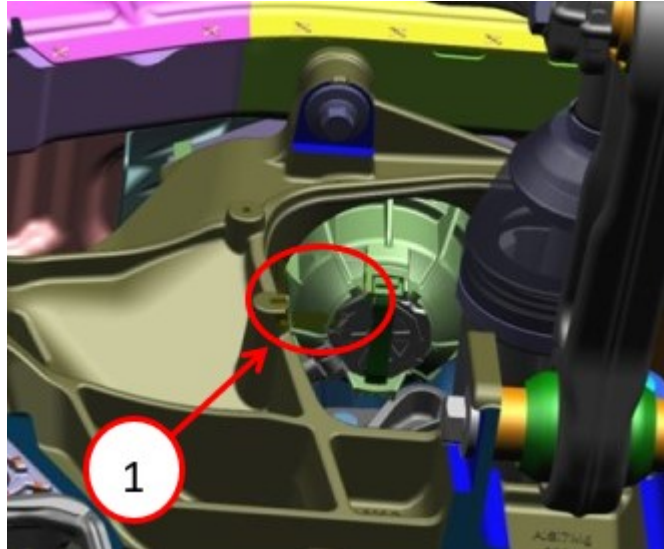
Fig. 1
Part Number Location

NOTE: Check the part number visible from the underside of the mount. (Fig. 1) If the mount(s) are already NIK AG or newer, further diagnosis is necessary.

2. If the symptom/condition is present and the mounts are not NIK AG or newer, proceed to [Step 1](#) of the Repair Procedure.

1. Replace the engine mounts with the updated engine mounts. Refer to the detailed service procedures available in DealerConnect> Service Library under: Engine, 3.6L / Engine Mounting / Insulator, Engine Mount / Removal and Installation.
