STAR ONLINE PUBLICATION

Case Number: S2223000053

Symptom/Vehicle Issue: Water Leak At Hard Top Front Corner Of Quarter Window

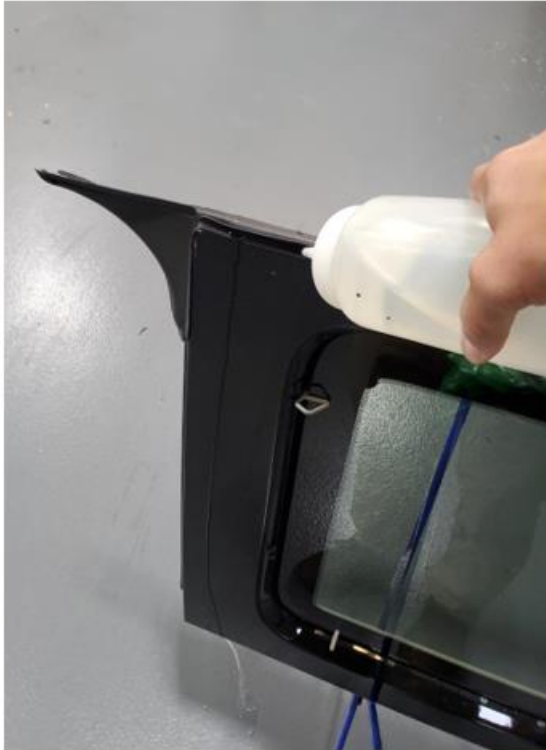
Test with water bottle

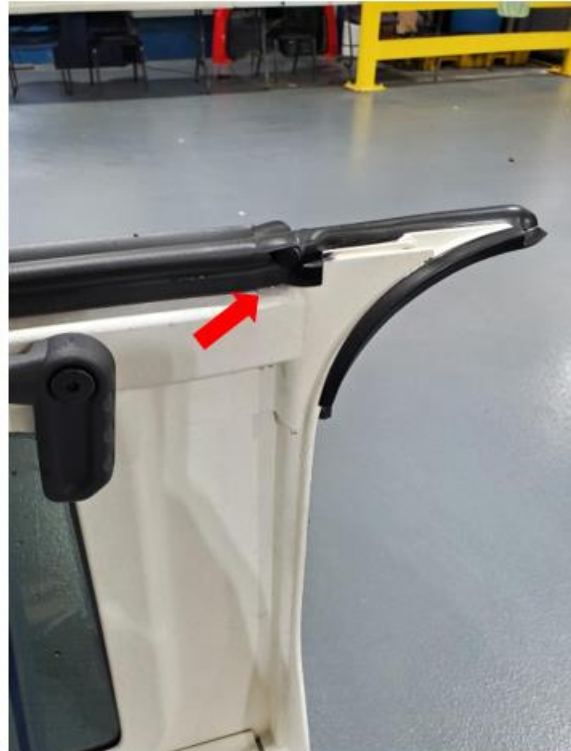
Check for water entering
from under seal

- 1) Remove quarter window from vehicle.
 - 2) Confirm water leak by slightly tipping quarter window forward so front edge is lower and pouring water along seal edge. Fig 1
 - 3) If water is dripping through seal (Fig 2), then pull back seal in this area and add a small butyl ball (about 1/4" diameter) to the corner of the quarter window. Use a piece of Mopar Butyl Tape (rope) 04076274ab or equivalent. Fig 3/4
 - 4) Re-seat seal with thumb pressure to bed the seal to the butyl. Re-test seal to see if leak still present (step 2).
 - 5) If water leak still present, try adjusting or adding more butyl to ensure water path is completely blocked.
- If water leak is not present, then reinstall quarter window back to vehicle.
