STAR ONLINE PUBLICATION

Case Number: S228A000014

Symptom/Vehicle Issue: Uconnect Box Require Service Message

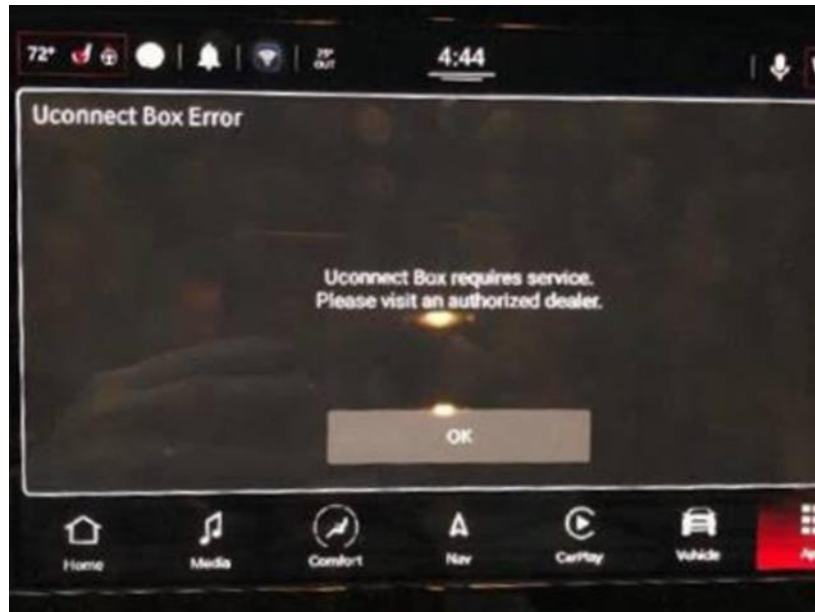
Fig 1

If the TBM part number shows lower than

- 68467662AI (WD), for example 68467662AH
- 68444865AI (RU), for example 68444865AH

A TBM software enhancement for “Uconnect box requires service” improvement will be tentatively late 3rd quarter 2022.

8. Do not replace the TBM module or radio if the issue cannot be duplicated.
