## STAR ONLINE PUBLICATION

**Case Number:** S2208000139

**Symptom/Vehicle Issue:** Check Engine Lamp (CEL) Multiple Diagnostic Trouble Codes (DTC)

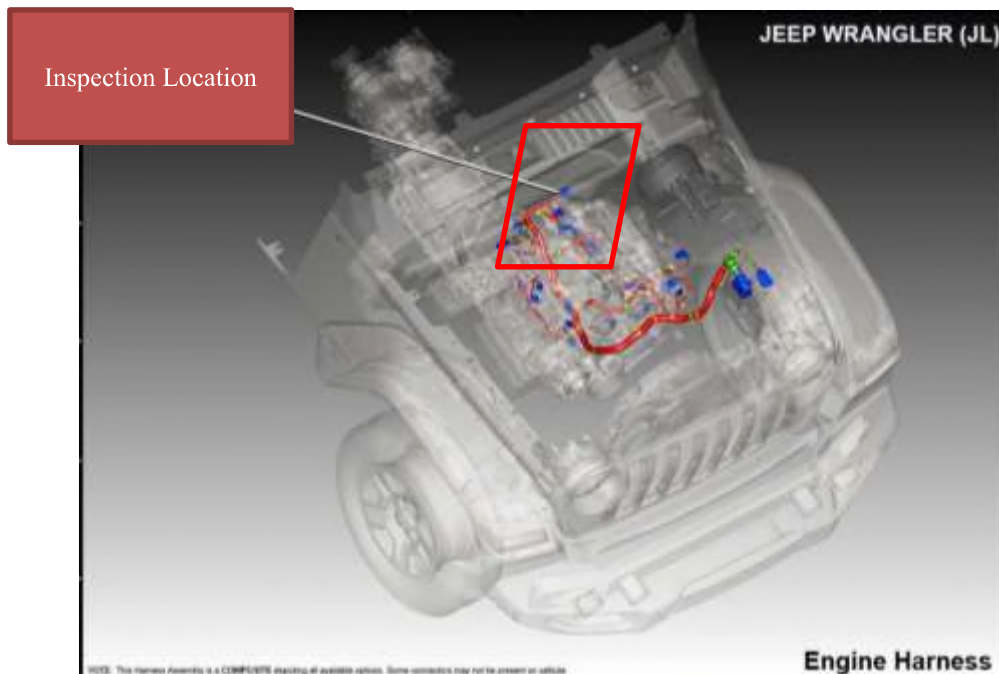
**Discussion:** Inspect the harness routing at the below highlighted area near the back right side of engine/bulkhead. Review the harness routing at the coolant hose clamps inspecting for harness damage chafing/cuts.

Repair any harness damage following the splice/repair guidelines within Service Library, **28 - DTC-Based Diagnostics / Circuit Testing Procedures / Standard Procedure WIRE SPLICING**. Rotate the hose clamps 180 degrees if any contact to ensure the greatest clearance for the harness. Isolate, secure and reposition the harness at any contact areas to complete the repair.
