STAR ONLINE PUBLICATION

Case Number: S2223000054

Symptom/Vehicle Issue: Washer Inoperative, Weak Or No Spray. Low Washer Indicator May Be Illuminated.

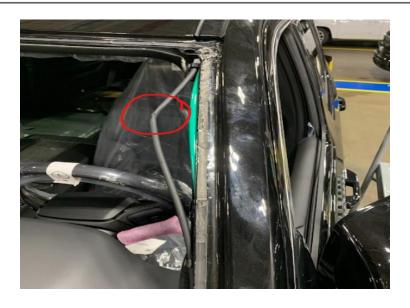
Kink example- under A pillar trim

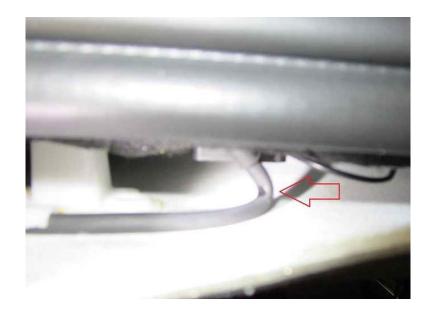
Sharp bend above headliner restricting washer fluid flow
