## STAR ONLINE PUBLICATION

**Case Number:** S2223000055

**Symptom/Vehicle Issue:** Window Regulator Motor Assembly Servicing

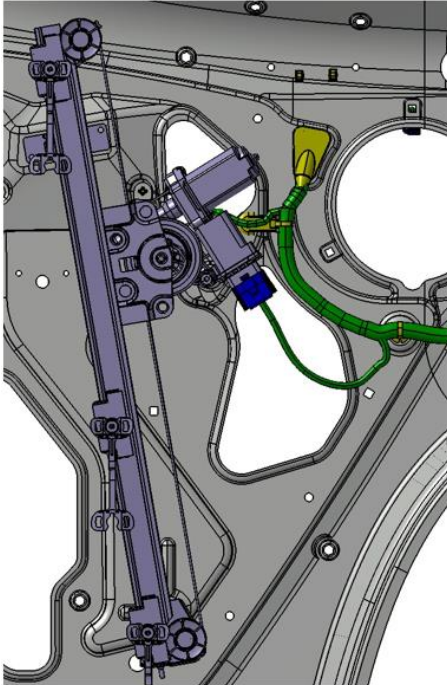
Original design

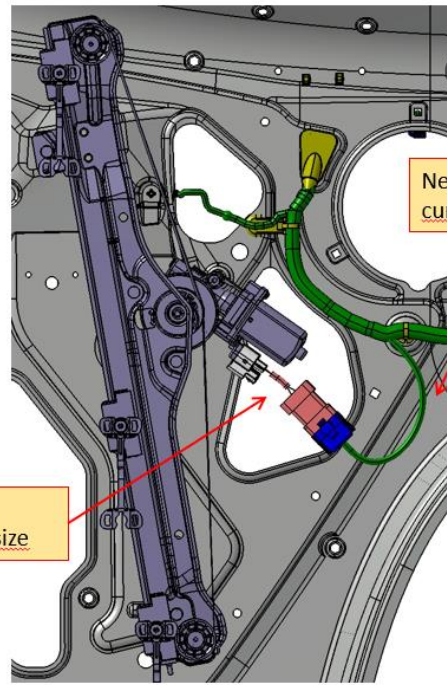
New design with bridge connector

**Discussion:** An update was made to use the latest design window regulator on all versions of VF Promaster vans. The part is visibly different but functions and installs the same. The motor wire connector may differ from the harness and the harness may not reach the motor connector. A “bridge connector” or jumper harness is available to adapt the new regulator assembly to the existing door harness. Part number 68462445AA is the bridge connector harness. Refer to Star Parts for current parts information. See figures below.

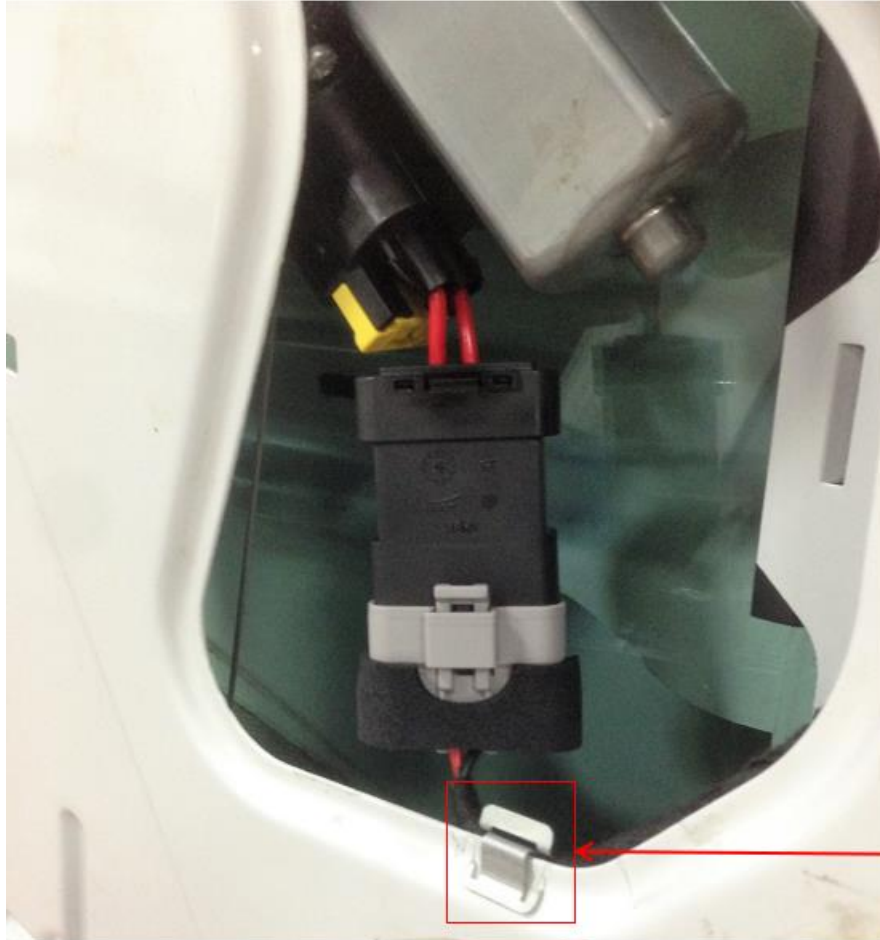
Bridge connector installed and clip shown in location.
