## STAR ONLINE PUBLICATION

**Case Number: S211800001 REV. B**

**Release Date: July 2022**

**Symptom/Vehicle Issue:** Malfunction Indicator Lamp (MIL) Illumination. Diagnostic Trouble Code (DTC) P0471 – Exhaust Pressure Sensor 1 Performance, Set.

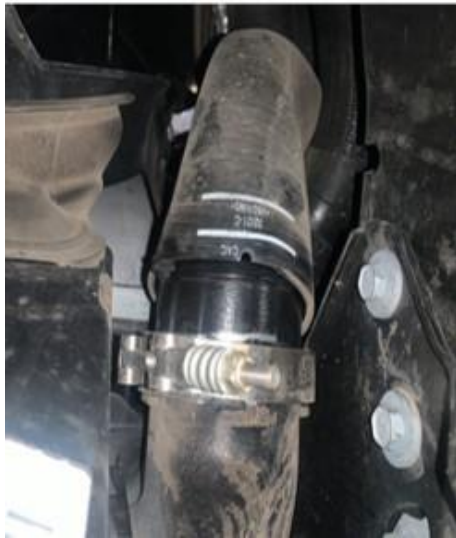
**Figure 1**

3. Inspect the exhaust system for restrictions (e.g. DOC/DPF face plugging).
4. If the exhaust is found restricted. Inspect the following areas for the cause of the restriction.
  - a. Restricted air intake
  - b. Restricted EGR systems,
  - c. Fuel system concerns causing over fueling, etc.
5. Inspect the Charge Air Cooler (CAC) hoses for loose connections/clamps, splits, and other damage which can also cause the exhaust system to plug up. Please see (Figures 1, 2, and 3).

6. Repair the cause of the exhaust restriction prior to replacing any of the exhaust components.

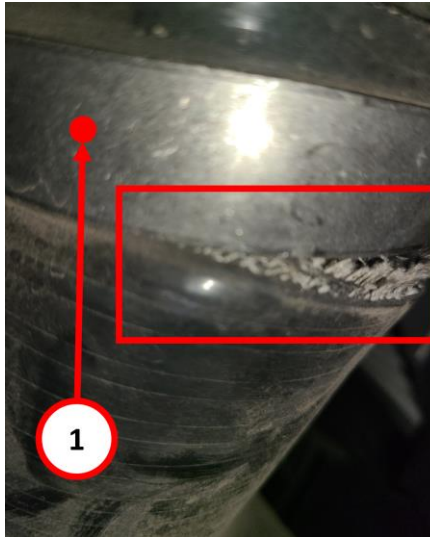
**Figure 3**

1. CAC Hose Clamp
