NUMBER: 08-142-22

Global Telematics Box Module (TBM2) Flash Over The Air Software Version Updates

2020 - 2022	(BV)	Jeep Renegade
2020 - 2022	(GA)	Alfa Romeo Giulia
2020 - 2022	(GU)	Alfa Romeo Stelvio

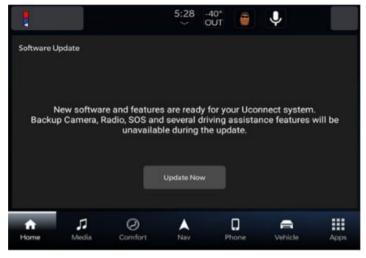
Fig. 2
Software Acceptance Screen

- 1. The vehicle needs to be in 'park'. The ignition needs to be in the off position.
- 2. If the customer selects "Update Now" they can shut off the vehicle and leave. The update will be completed automatically.

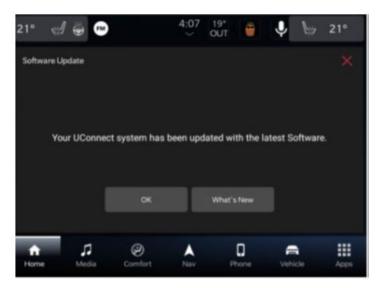
Fig. 3
Software Update Confirmation Screen

3. Upon completion of update, the radio will display a confirmation message (Fig. 3) .
