NUMBER: 23-028-22

Right Front A-Pillar Sealing Plug Missing

2022 (KL) Jeep Cherokee

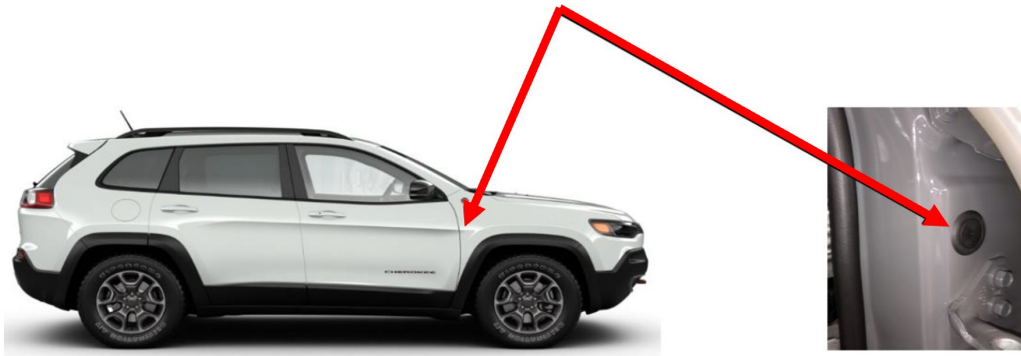
Fig. 1
A-Pillar Sealing Plug Location

1. Open the right front door and inspect for the sealing plug (Fig. 1) .

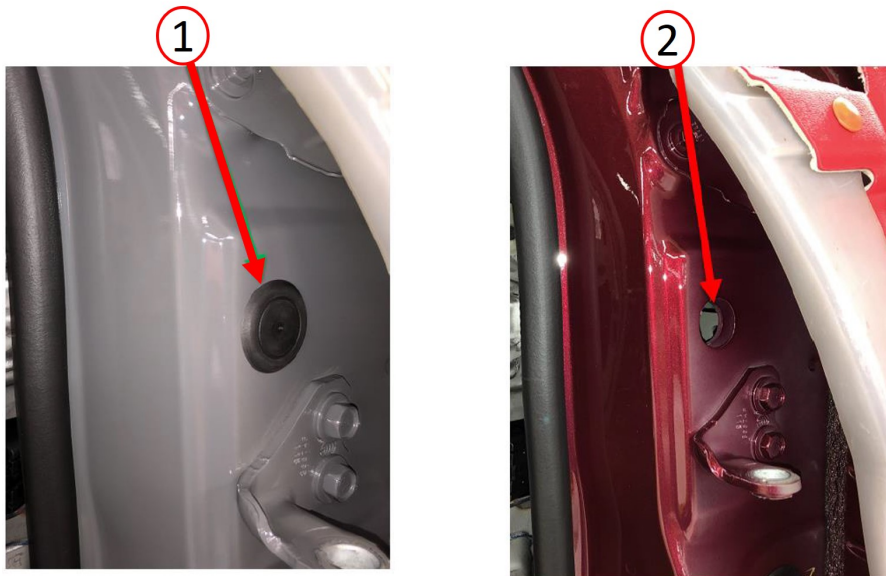
Fig. 2
Sealing Plug Installed or Missing

2. Was the sealing plug in the A-pillar (Fig. 2) ?
 - YES>>> This bulletin has been completed, use inspect LOP (23-00-41-93) to close the active RSU.
 - NO>>> Proceed to [Step 3](#).

- 1 - Properly Installed Sealing Plug
2 - Missing Sealing Plug

8. Install the missing sealing plug in the A-pillar (Fig. 2) .

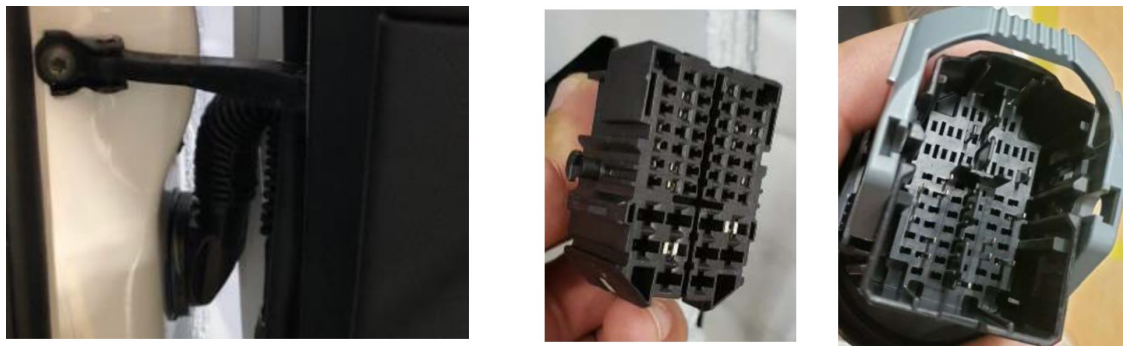
Fig. 3
Door Electrical Connector

4. Remove wiring harness from A-pillar (Fig. 3) .

5. Inspect electrical connection for corrosion (Fig. 3) .

6. Clean the electrical connection (Fig. 3) .

7. Apply dielectric connector grease to connector.
