# MIL ON With DTCs P0087 and/or P107A2A at High Altitude and With High Temperatures

YEAR(S)	MODEL(S)	ADDITIONAL INFORMATION
2020 - 2022	Highlander, Highlander HV	
2021 - 2022	Sienna HV

Some 2020 – 2022 Highlander and Highlander Hybrid and 2021 – 2022 Sienna Hybrid vehicles may exhibit a MIL ON condition with Diagnostic Trouble Codes (DTCs) P0087 (Fuel Rail/System Pressure – Too Low) and/or P107A2A (Fuel Rail Pressure Sensor (Low) Signal Stuck in Range) present. This condition may occur when the vehicle is operated at high altitude and high temperature; typically, above 3,300 feet (1,000 meters) and ambient temperature above 85°F (30°C). The Engine Control Module (ECM) (SAE term: Powertrain Control Module/PCM) logic has been modified to reduce the possibility of this condition occurring. Follow the Repair Procedure in this bulletin to address this condition.

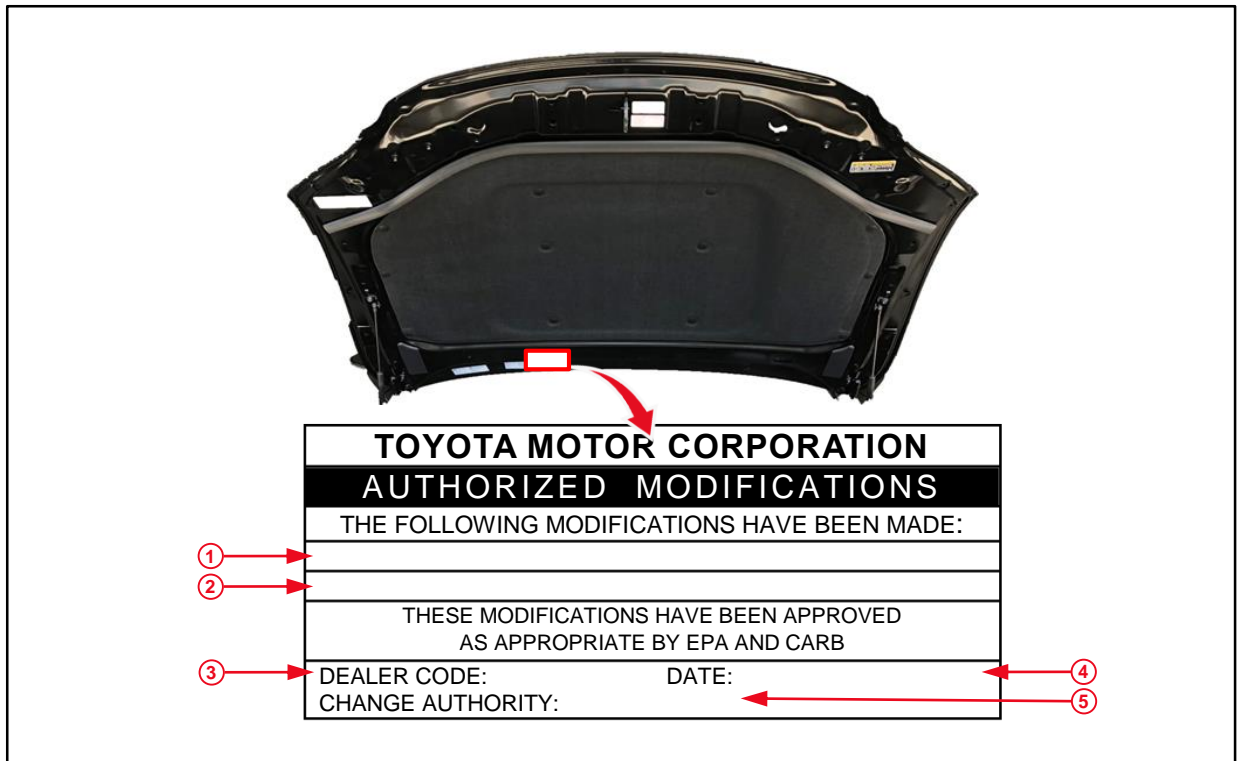
**Figure 1. Location of Authorized Modifications Label on 2020 – 2022 Highlander and Highlander HV**

<b>1</b>	Replacement ECM (PCM) Part Number (e.g., 89661-0EB65)
<b>2</b>	New Calibration ID (e.g., 896630E62500)
<b>3</b>	Dealer Code

<b>4</b>	Date Completed
<b>5</b>	This SB Number

5. Prepare and install the Authorized Modifications Label.
  - A. Using a permanent marker, enter the following information on the label:
    - ECM (PCM) part number [*Refer to the **Parts Information** section for the **NEW PART NUMBER***]
    - Calibration ID(s) [*Refer to the **Calibration Information** section for the **NEW CALIBRATION ID***]
    - Dealer Code
    - Repair Date
    - Change Authority [***This bulletin number***]
  - B. Install the Authorized Modifications Label onto the vehicle at the locations shown in Figures 1 and 2. The Authorized Modifications Label is available through the MDC, P/N 00451-00001-LBL.
6. Using Techstream, perform a Health Check to confirm that the NEW calibrations updated successfully.
7. Clear DTCs and confirm the condition is no longer present.

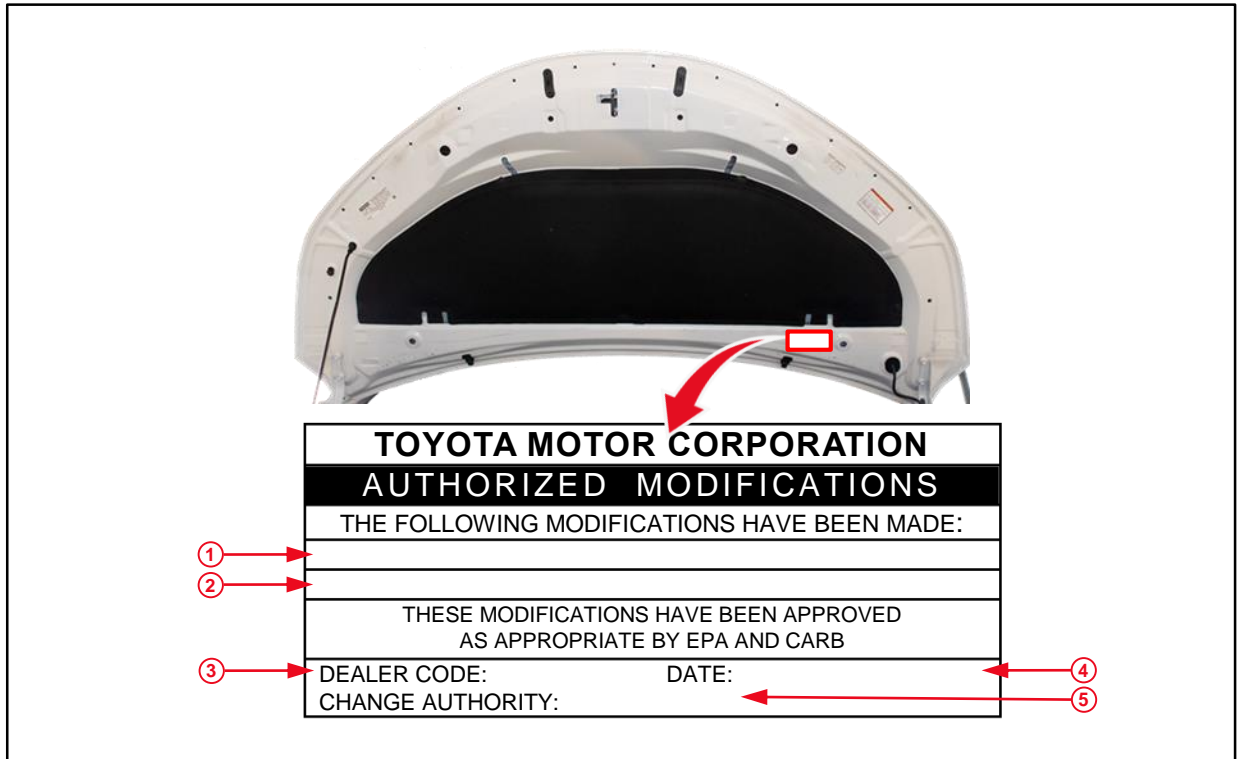
Figure 2. Location of Authorized Modifications Label on 2021 – 2022 Sienna HV

<b>1</b>	Replacement ECM (PCM) Part Number (e.g., 89661-08652)
<b>2</b>	New Calibration ID (e.g., 896630857201)
<b>3</b>	Dealer Code

<b>4</b>	Date Completed
<b>5</b>	This SB Number
