# Pop/Clunk Noise on Initial Engine Start

**Service Category** Drivetrain

**Section** Automatic Transmission/Transaxle

YEAR(S)	MODEL(S)	ADDITIONAL INFORMATION
2022 - 2023	Tundra

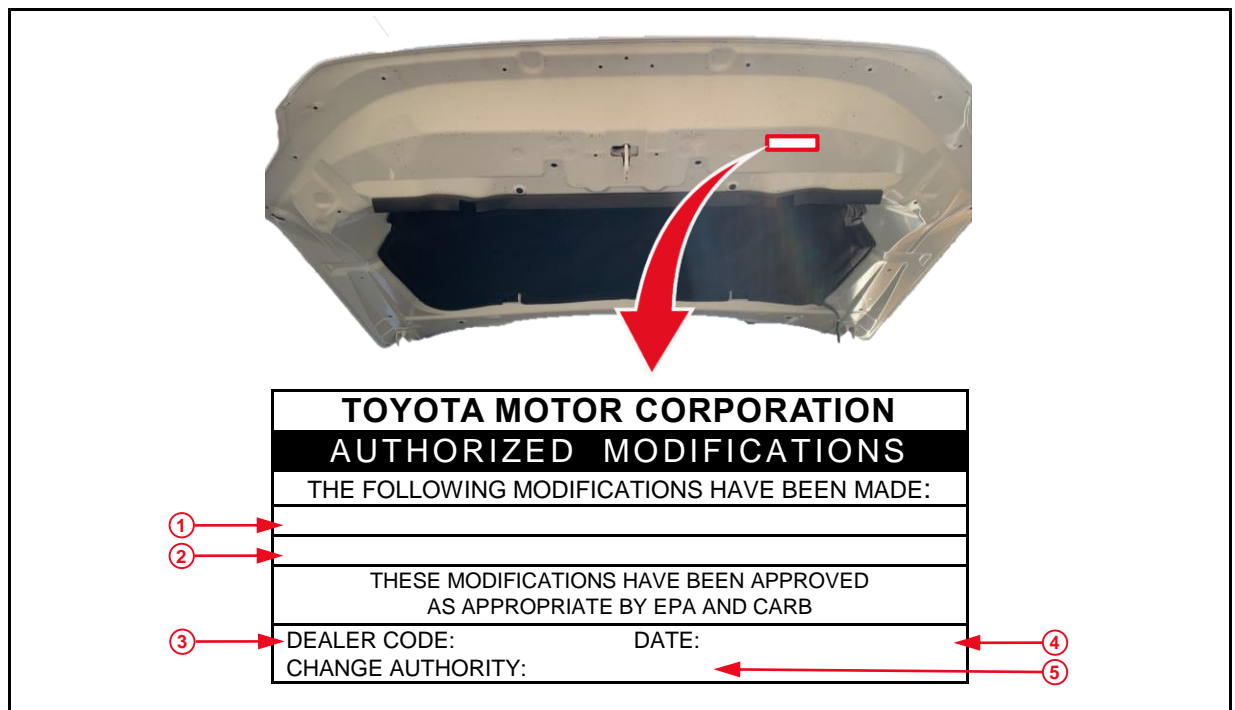
**Figure 1. Location of Authorized Modifications Label on 2022 – 2023 Tundra**

2. Use Techstream to confirm if the TCM calibration has been updated and check for the Authorized Modifications Label affixed to the vehicle in the location shown below. Is the calibration ID listed in Techstream and on the label the latest TCM calibration?
  - **YES** — This bulletin does NOT apply. Continue diagnosis using the applicable Repair Manual.
  - **NO** — Continue to step 3.

B. Install the Authorized Modifications Label onto the vehicle at the location shown in Figure 1. The Authorized Modifications Label is available through the MDC, P/N 00451-00001-LBL (USA) or 00451-00002-MEX (Mexico).
