Hesitation From Stop and Surge Concerns

Service Category Drivetrain

Section Automatic Transmission/Transaxle

YEAR(S)	MODEL(S)	ADDITIONAL INFORMATION
2022 - 2023	Tundra

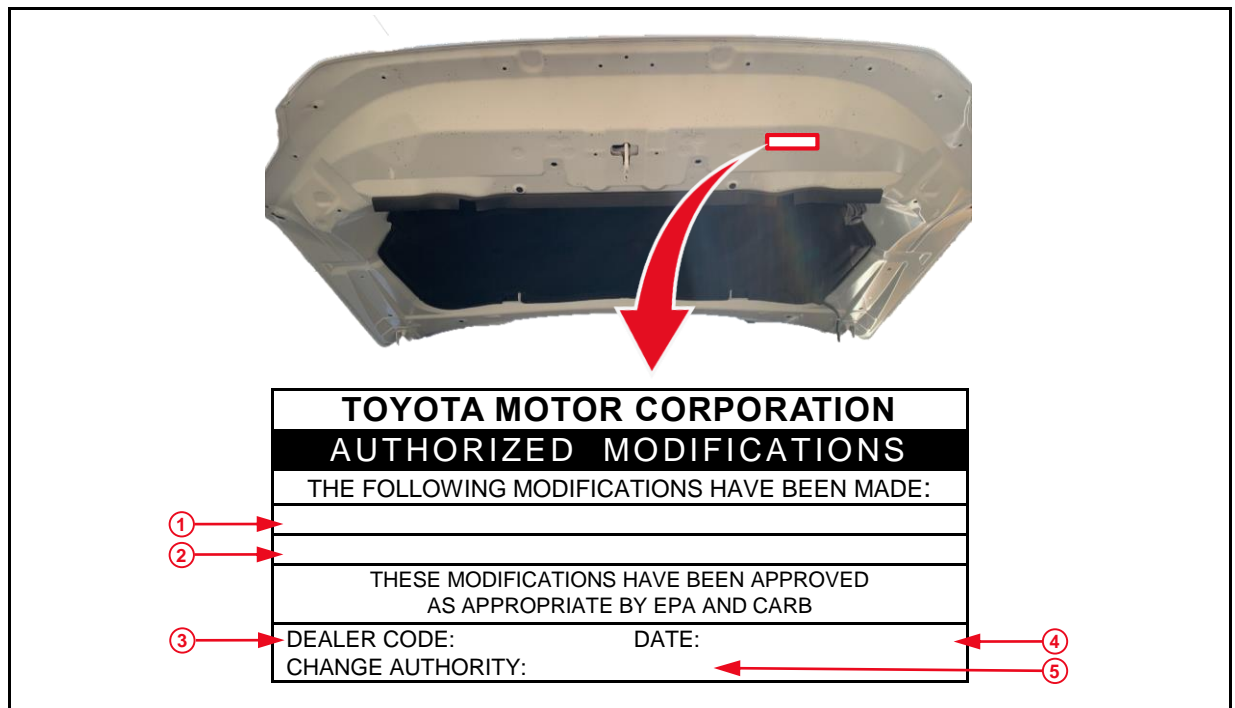
Figure 1. Location of Authorized Modifications Label on 2022 – 2023 Tundra

1	Replacement TCM Part Number (e.g., 89530-60680)
2	New Calibration ID (e.g., 8A2100C01400)
3	Dealer Code

4	Date Completed
5	This SB Number

B. Install the Authorized Modifications Label onto the vehicle at the location shown in Figure 1. The Authorized Modifications Label is available through the MDC, P/N 00451-00001-LBL (USA) or 00451-00002-MEX (Mexico).
