Subject Hybrid Radio - Error Message Pop-ups		Market USA
Service Category Audio/Visual/Telematics	Section Cellular Communication	
Applicability 2022 Tundra/Tundra HV

Hybrid Radio - Error Message Pop-ups

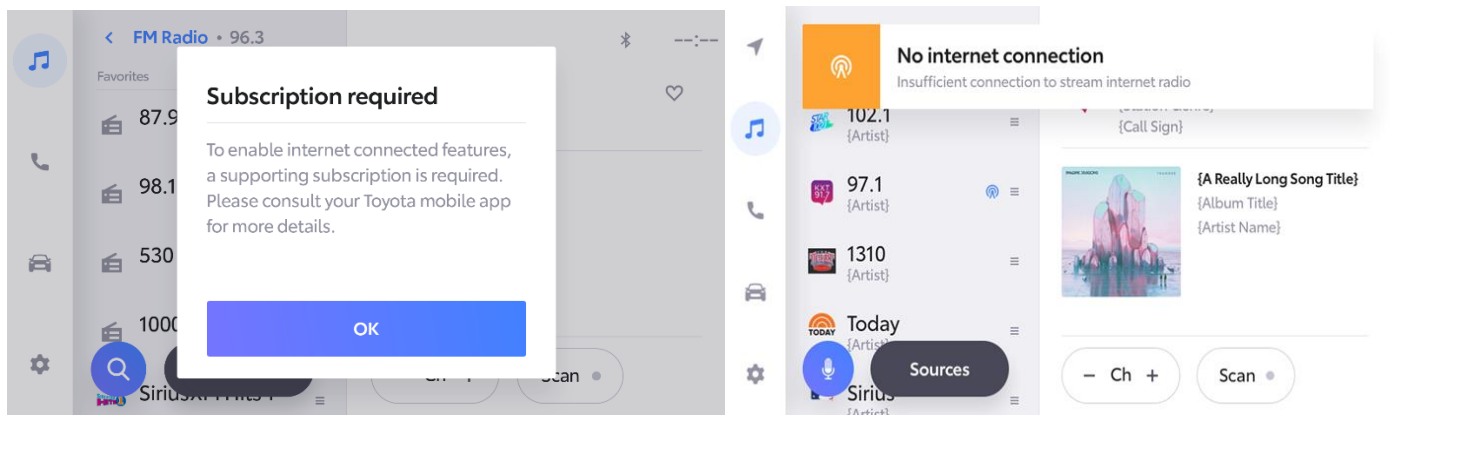
Some 2022MY Tundra vehicles may experience one of the following pop-up messages if “Hybrid radio” has been enabled. Please follow the steps below to correct the condition.
