Loose Side-seal Retainer Under the Tonneau Cover Weather Strip/Side-seal

YEAR(S)	MODEL(S)	ADDITIONAL INFORMATION
2022 - 2023	Tundra, Tundra HV

Some 2022 – 2023 model year Tundra and Tundra Hybrid vehicles may exhibit loose side-seal retainer(s) that lie under the tonneau cover weatherstrip/side-seal. Follow the Repair Procedure in this bulletin to address this condition.

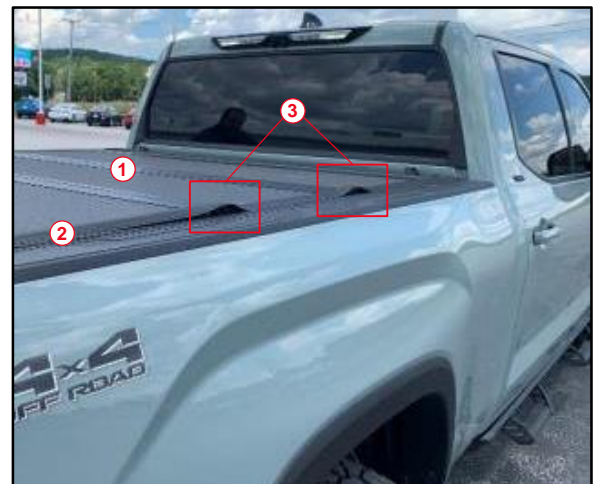
Figure 1.

- Confirm the condition exists.
Does the vehicle exhibit loose side-seal retainer(s) that lie under the tonneau cover weatherstrip/side-seal?
 - YES** — Go to step 2.
 - NO** — This bulletin does NOT apply. Continue diagnosis using the applicable Repair Manual.

1	Tonneau Cover
2	Side-seal/Weather Strip
3	Loose Side-seal Retainer

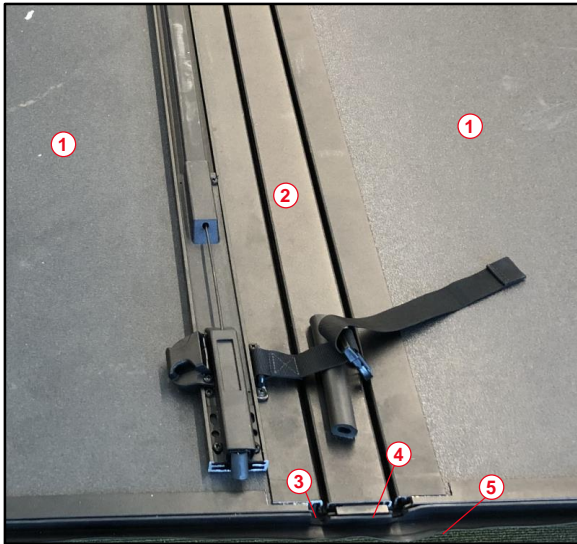
Figure 2. Bottom View of the Tonneau Cover

1	Tonneau Panel
2	Aluminum Rubber-hinge Rail
3	Rubber Hinge
4	Side-seal Retainer
5	Side-seal
