**22MY Tundra/HV - MIL ON w/DTC(s) P017400, P043000 - Debris In Bank 2 Fuel Delivery Pipe**

**22MY Tundra/HV**

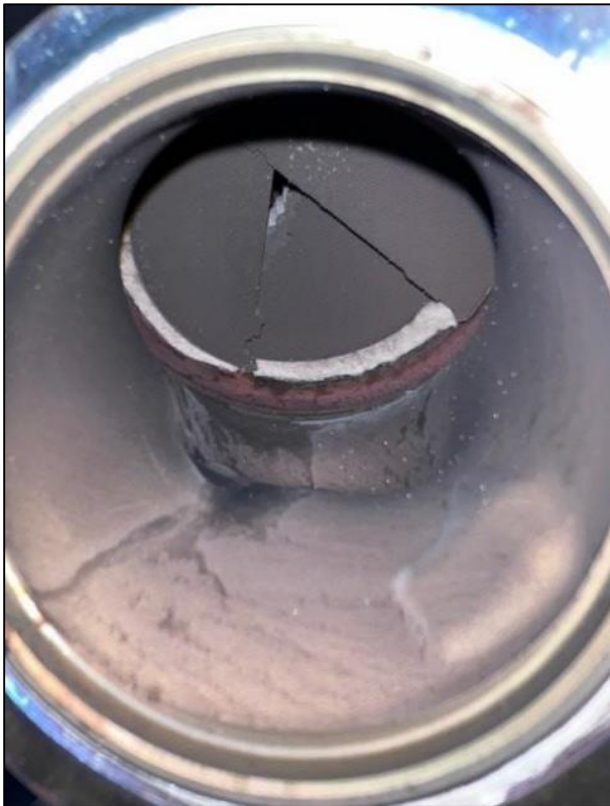
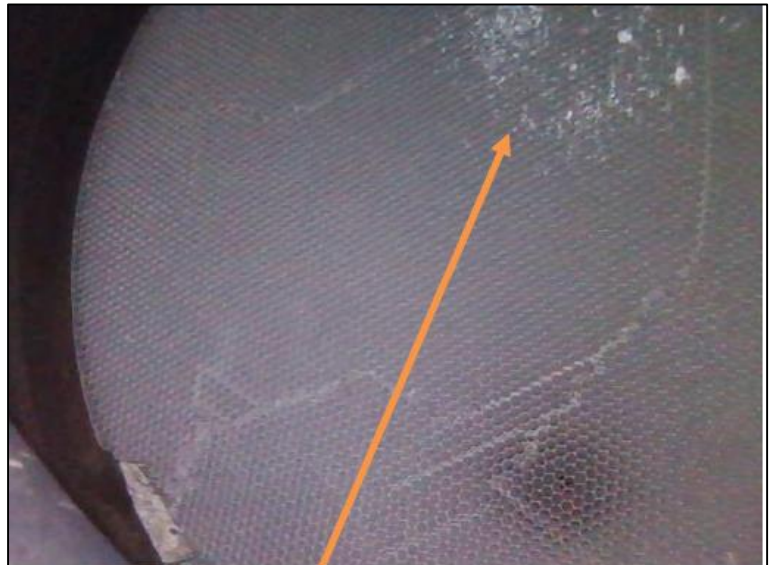
Some 22MY Tundra/HV vehicles may experience a MIL ON w/DTC(s) P017400, P043000. Other symptoms of this issue include poor acceleration. A lean condition may cause damage to the internal catalyst in the catalytic converter. See pictures below for condition:

Damage to bank 2 catalytic converter.

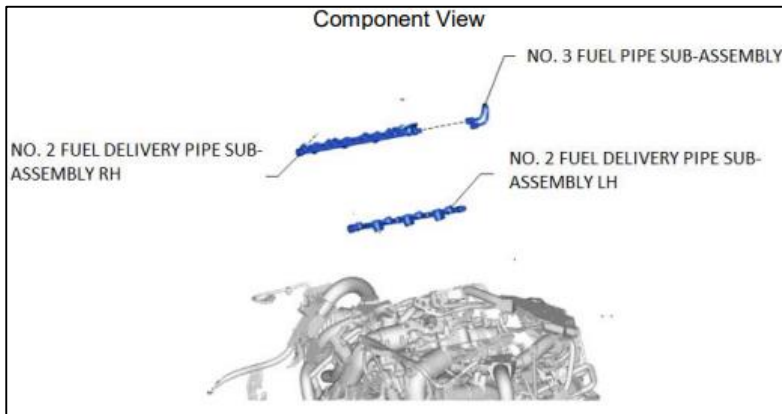
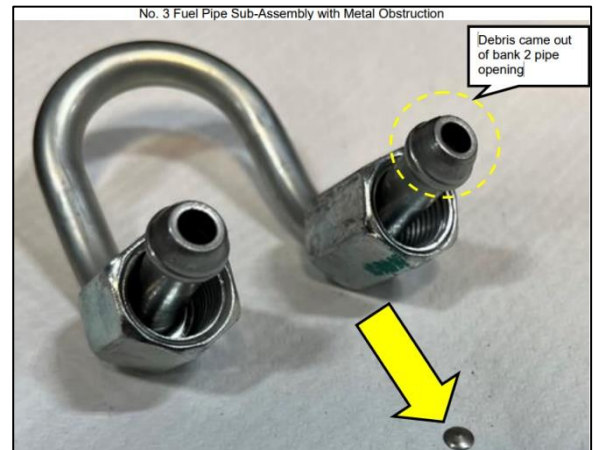
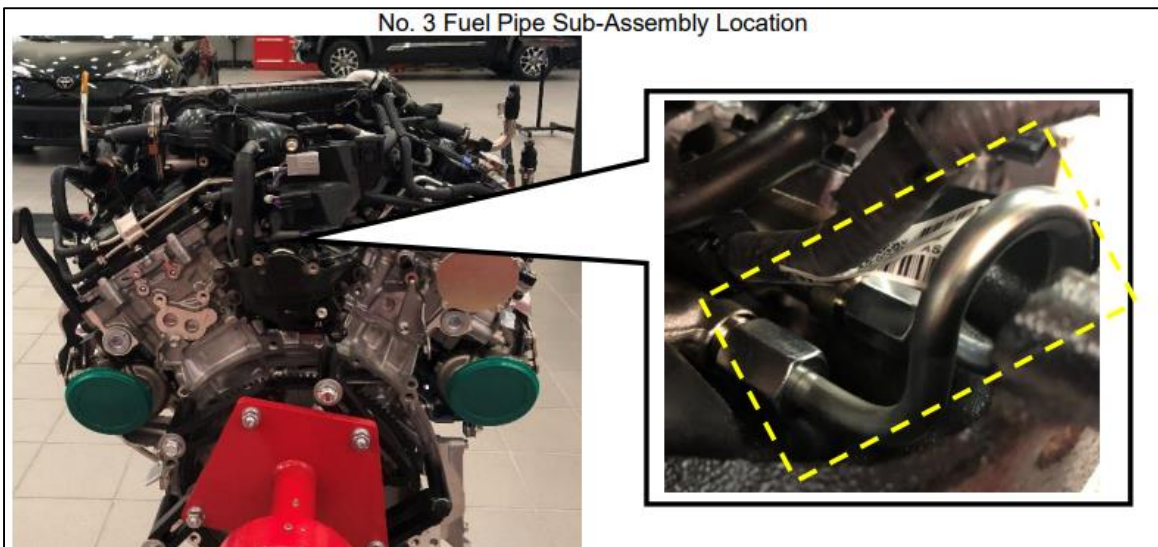
If this condition is identified, it is recommended to disassemble the No.3 fuel pipe sub assembly to inspect for obstruction and debris in the bank 2 high pressure fuel rail. Debris in the fuel rail can cause fuel blockage leading to a lean condition and poor acceleration. See below for details:

If this condition is identified, it is important to check for debris in the LH No.2 Fuel Delivery Pipe and No.3 Fuel Pipe Sub Assy connection port to help eliminate any repeat repairs for customers. Please create a TAS case and contact TAS for instruction prior to diagnosing or repairing of the vehicle. Please save all parts and/or details and submit a field report.
